# Access Compliance Report

## Public Rights-of-Way

### (Curb Ramps)

Intersection ID: 10030508	Main Street: LITTLE_GEM_LN	Cross Street: N/A	Location: NE
ADA ID: 6C9921ED654D	Ramp Type: BlendTrans1	Initial Pass/Fail: Fail	Overall Compliance: No
Severity Score: 12.5			
Codes/Mitigation Info/Possible Solution		Field Measurements/Component Compliance

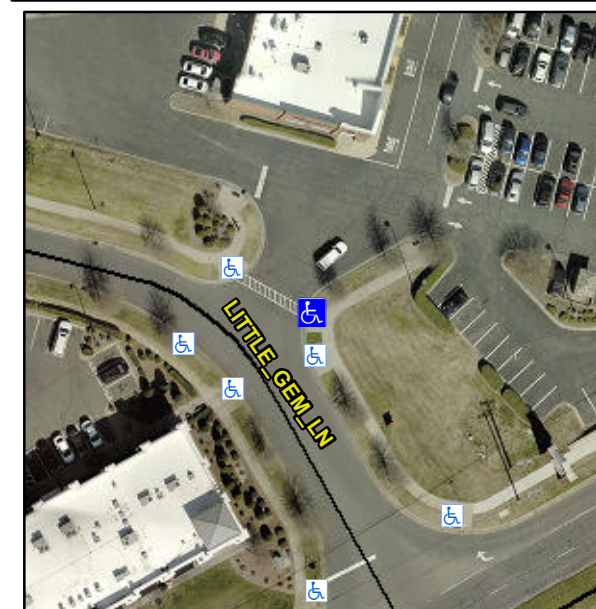
Compliance	Description	Data	Compliance	Description	Data
N/A	Ramp Length (in)	103.0	Yes	BlendTrans Slope (%)	4.6
Yes	Ramp Width (in)	49.5	No	BlendTrans XSlope (%)	6.5
N/A	Flare Type LT	N/A	N/A	Flare Type RT	N/A
N/A	Flare Slope LT (%)	N/A	N/A	Flare Slope RT (%)	N/A
N/A	Flare Traversable LT?	N/A	N/A	Flare Traversable RT?	N/A
N/A	Landing Length (in)	N/A	N/A	DWS Provided?	N/A
N/A	Landing Width (in)	N/A	N/A	DWS Contrast?	N/A
N/A	Landing Slope (%)	N/A	N/A	DWS Length (in)	N/A
N/A	Landing X Slope (%)	N/A	N/A	DWS Full Width?	N/A
N/A	Landing Curb? (Y/N)	N/A	N/A	DWS Offset (in)	N/A
N/A	Shared Landing?	N/A			
N/A	Gutter Ponding?	N/A	N/A	Gutter Slope (%)	N/A
N/A	Gutter Lip Ht (in)	N/A	N/A	Gutter X Slope (%)	N/A
N/A	Painted X Walk1?	Yes	N/A	Painted X Walk2?	N/A
	X Walk 1 Direction	To NW		X Walk 2 Direction	N/A
	X Walk 1 Width (in)	63.0		X Walk 2 Width (in)	N/A
	X Walk 1 Slope (%)	0.7		X Walk 2 Slope (%)	N/A
	X Walk 1 X Slope (%)	6.5		X Walk 2 X Slope (%)	N/A

N/A	Ramp inside XWalk1?	Yes	N/A	Ramp inside XWalk2?	N/A
	Road Slope (%)	5.4		Clear Space?	N/A
	Road X Slope (%)	2.7	N/A	Clear Space to XWalk (in)	N/A
N/A	Any Obstructions?	N/A	N/A	Storm Grate/Utility Hazard?	N/A
	Obstruction Type			Storm Grate/Utility Type	
		N/A			N/A
			Yes	Surface Condition? (G/P)	Good
			N/A	Curb Slope (%)	3.9

**Remove & Replace Curb Ramp With Two New Directional Ramps or Equivalent.**

**R304.5.3**

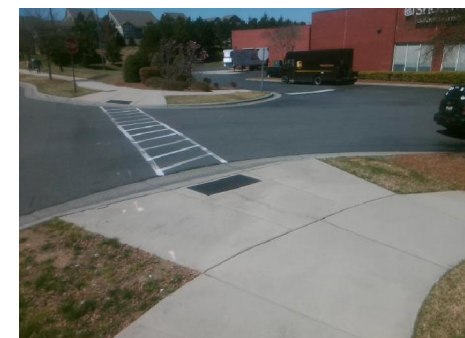
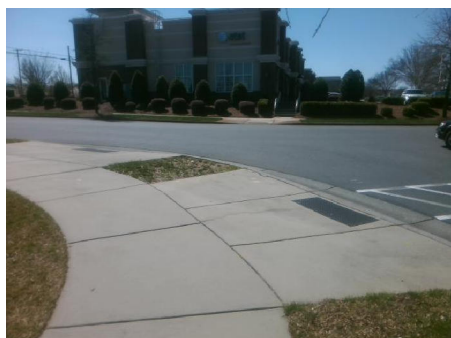
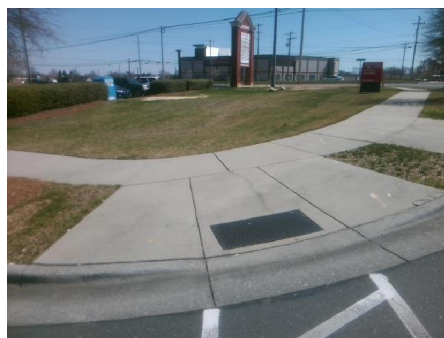
Street 1 Name	<b>ENTRANCE</b>
Stop Condition-Street 1	<b>StopSign</b>
Street 2 Name	<b>N/A</b>
Stop Condition-Street 2	<b>N/A</b>
