# Access Compliance Report

## Public Rights-of-Way

### (Curb Ramps)

Intersection ID: 14266	Main Street: BRIAR_CREEK_RD	Cross Street: CREIGHTON_DR	Location: E
ADA ID: 6C9FC03CB7FB	Ramp Type: PerpDiag	Initial Pass/Fail: Fail	Overall Compliance: No
Severity Score: 46.25			
Codes/Mitigation Info/Possible Solution		Field Measurements/Component Compliance

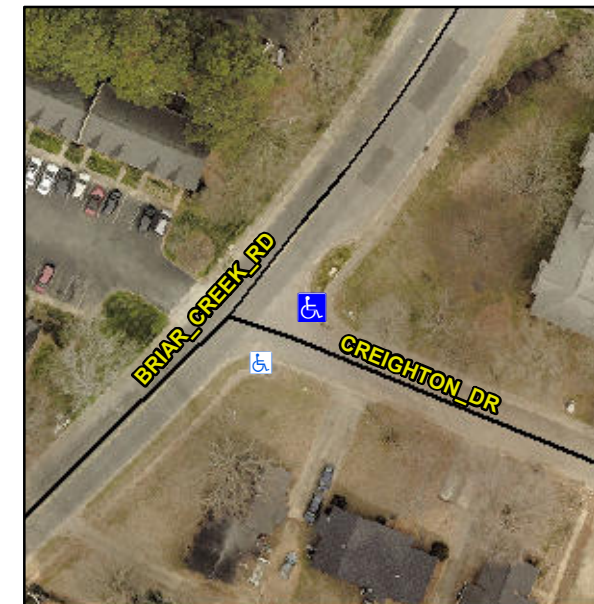
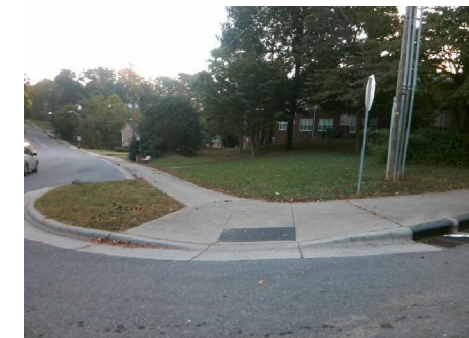
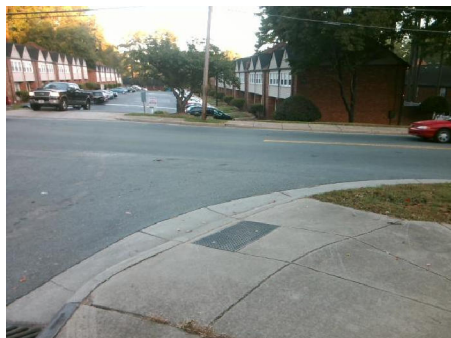
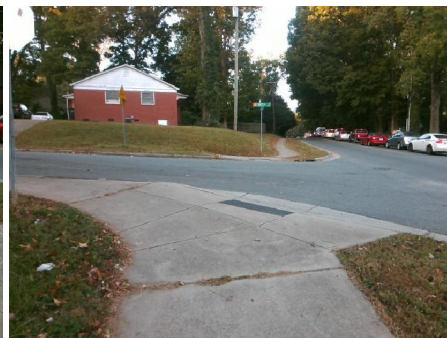
Compliance	Description	Data	Compliance	Description	Data
N/A	Ramp Length (in)	55.0	No	Ramp Slope (%)	8.4
No	Ramp Width (in)	47.0	No	Ramp XSlope (%)	12.8
N/A	Flare Type LT	N/A	N/A	Flare Type RT	N/A
N/A	Flare Slope LT (%)	N/A	N/A	Flare Slope RT (%)	N/A
N/A	Flare Traversable LT?	N/A	N/A	Flare Traversable RT?	N/A
N/A	Landing Length (in)	N/A	N/A	DWS Provided?	N/A
N/A	Landing Width (in)	N/A	N/A	DWS Contrast?	N/A
N/A	Landing Slope (%)	N/A	N/A	DWS Length (in)	N/A
N/A	Landing X Slope (%)	N/A	N/A	DWS Full Width?	N/A
N/A	Landing Curb? (Y/N)	N/A	N/A	DWS Offset (in)	N/A
N/A	Shared Landing?	N/A			
N/A	Gutter Ponding?	N/A	N/A	Gutter Slope (%)	N/A
N/A	Gutter Lip Ht (in)	N/A	N/A	Gutter X Slope (%)	N/A
N/A	Painted X Walk1?	No	N/A	Painted X Walk2?	No
	X Walk 1 Direction	To NW		X Walk 2 Direction	To SW
N/A	X Walk 1 Width (in)	N/A	N/A	X Walk 2 Width (in)	N/A
	X Walk 1 Slope (%)	6.2		X Walk 2 Slope (%)	5.8
	X Walk 1 X Slope (%)	4.8		X Walk 2 X Slope (%)	9.3

N/A	Ramp inside XWalk1?	N/A	N/A	Ramp inside XWalk2?	N/A
	Road Slope (%)	10.5	N/A	Clear Space?	N/A
	Road X Slope (%)	1.0	N/A	Clear Space to XWalk (in)	N/A
N/A	Any Obstructions?	N/A	N/A	Storm Grate/Utility Hazard?	N/A
	Obstruction Type			Storm Grate/Utility Type	
		N/A			N/A
			Yes	Surface Condition? (G/P)	Good

**Remove & Replace Curb Ramp With Two New Directional Ramps or Equivalent.**

**Not Found, R304.5.1, R304.2.2, R304.5.3**
