Access Compliance Report

Public Rights-of-Way

(Curb Ramps)

Intersection ID: 47907	Main Street: E_MALLARD_CREEK_CHURCH_RD	Cross Street: JOHN_KIRK_DR	Location: S
ADA ID: 6CB606D1D7BD	Ramp Type: Perp	Initial Pass/Fail: Fail	Overall Compliance: No
Severity Score: 10			
Codes/Mitigation Info/Possible Solution		Field Measurements/Component Compliance

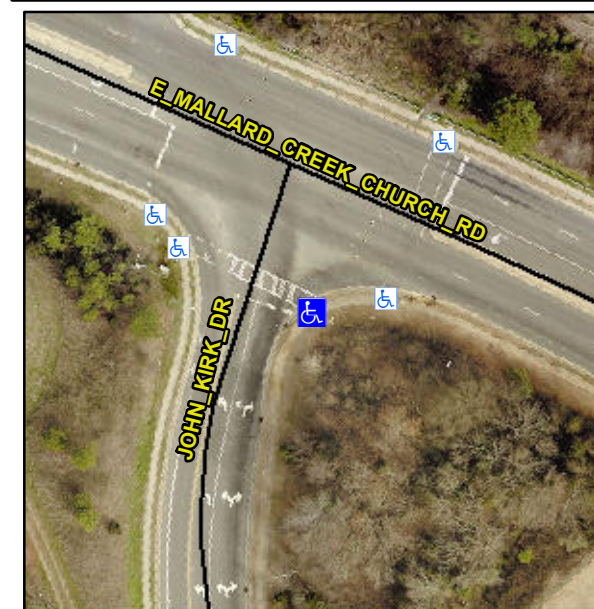
Compliance	Description	Data	Compliance	Description	Data
N/A	Ramp Length (in)	72.5	Yes	Ramp Slope (%)	7.5
No	Ramp Width (in)	43.0	No	Ramp XSlope (%)	2.6
N/A	Flare Type LT	N/A	N/A	Flare Type RT	N/A
N/A	Flare Slope LT (%)	N/A	N/A	Flare Slope RT (%)	N/A
N/A	Flare Traversable LT?	N/A	N/A	Flare Traversable RT?	N/A
N/A	Landing Length (in)	N/A	N/A	DWS Provided?	N/A
N/A	Landing Width (in)	N/A	N/A	DWS Contrast?	N/A
N/A	Landing Slope (%)	N/A	N/A	DWS Length (in)	N/A
N/A	Landing X Slope (%)	N/A	N/A	DWS Full Width?	N/A
N/A	Landing Curb? (Y/N)	N/A	N/A	DWS Offset (in)	N/A
N/A	Shared Landing?	N/A			
N/A	Gutter Ponding?	N/A	N/A	Gutter Slope (%)	N/A
N/A	Gutter Lip Ht (in)	N/A	N/A	Gutter X Slope (%)	N/A
N/A	Painted X Walk1?	Yes	N/A	Painted X Walk2?	N/A
	X Walk 1 Direction	To NW		X Walk 2 Direction	N/A
N/A	X Walk 1 Width (in)	101.0	N/A	X Walk 2 Width (in)	N/A
	X Walk 1 Slope (%)	1.9		X Walk 2 Slope (%)	N/A
	X Walk 1 X Slope (%)	1.4		X Walk 2 X Slope (%)	N/A

N/A	Ramp inside XWalk1?	Yes	N/A	Ramp inside XWalk2?	N/A
	Road Slope (%)	N/A	N/A	Clear Space?	N/A
	Road X Slope (%)	N/A	N/A	Clear Space to XWalk (in)	N/A
N/A	Any Obstructions?	N/A	N/A	Storm Grate/Utility Hazard?	N/A
	Obstruction Type			Storm Grate/Utility Type	
		N/A			N/A
			Yes	Surface Condition? (G/P)	Good

Remove & Replace Entire Ramp.

R304.5.1, R304.5.3
