Intersection ID: 45861	Main Street: MADDUX_CT	Cross Street: HENDERSON_OAKS_DR	Location:	NE
ADA ID: 6CB8715E67BB	Ramp Type: PerpDiag	Initial Pass/Fail: Fail	Overall Compliance: No	Severity Score: 61.25

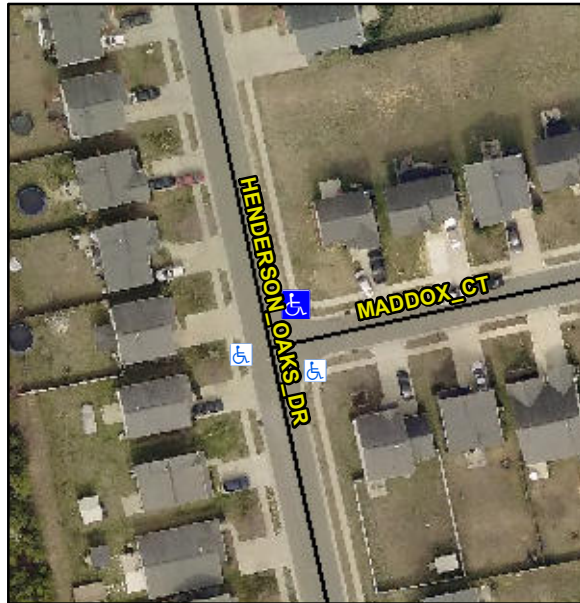
**Not Found, R304.5.1, R304.2.2,  
R304.5.3**

Compliance	Description	Data	Compliance	Description	Data
N/A	Ramp Length (in)	48.0	No	Ramp Slope (%)	14.9
No	Ramp Width (in)	25.0	No	Ramp XSlope (%)	4.5
N/A	Flare Type LT	N/A	N/A	Flare Type RT	N/A
N/A	Flare Slope LT (%)	N/A	N/A	Flare Slope RT (%)	N/A
N/A	Flare Traversable LT?	N/A	N/A	Flare Traversable RT?	N/A
N/A	Landing Length (in)	N/A	N/A	DWS Provided?	N/A
N/A	Landing Width (in)	N/A	N/A	DWS Contrast?	N/A
N/A	Landing Slope (%)	N/A	N/A	DWS Length (in)	N/A
N/A	Landing X Slope (%)	N/A	N/A	DWS Full Width?	N/A
N/A	Landing Curb? (Y/N)	N/A	N/A	DWS Offset (in)	N/A
N/A	Shared Landing?	N/A			
N/A	Gutter Ponding?	N/A	N/A	Gutter Slope (%)	N/A
N/A	Gutter Lip Ht (in)	N/A	N/A	Gutter X Slope (%)	N/A
N/A	Painted X Walk1?	No	N/A	Painted X Walk2?	No
	X Walk 1 Direction	To W		X Walk 2 Direction	To S
N/A	X Walk 1 Width (in)	N/A	N/A	X Walk 2 Width (in)	N/A
	X Walk 1 Slope (%)	1.0		X Walk 2 Slope (%)	4.2
	X Walk 1 X Slope (%)	3.7		X Walk 2 X Slope (%)	1.3

N/A	Ramp inside XWalk1?	N/A	N/A	Ramp inside XWalk2?	N/A
	Road Slope (%)	3.6	N/A	Clear Space?	N/A
	Road X Slope (%)	3.6	N/A	Clear Space to XWalk (in)	N/A
N/A	Any Obstructions?	N/A	N/A	Storm Grate/Utility Hazard?	N/A
	Obstruction Type			Storm Grate/Utility Type	
		N/A			N/A
			Yes	Surface Condition? (G/P)	Good

**Remove & Replace Curb Ramp With Two New Directional Ramps or Equivalent.**
