## **Access Compliance Report Public Rights-of-Way** (Curb Ramps)

Intersection ID: 14103 Main Street: HARDING PL **Cross Street: BERKELEY\_AV** Location: ADA ID: 6CB89A334BFF Ramp Type: PerpDiag Initial Pass/Fail: Fail **Overall Compliance: No Severity Score:** 37.5

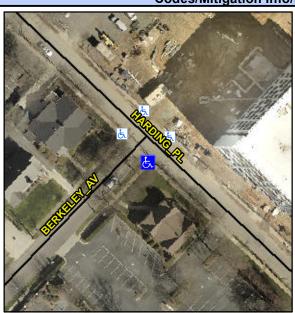
Field Measurements/Component Compliance							
Compli		liance Description	Data	Comp	liance	Description	Data
	N/A	Ramp Length (in)	50.0	No	Ramı	Slope (%)	9.4
	Yes	Ramp Width (in)	48.0	No	Ram	XSlope (%)	8.4
	N/A	Flare Type LT	N/A	N/A	Flare	Type RT	N/A
	N/A	Flare Slope LT (%)	N/A	N/A	Flare	Slope RT (%)	N/A
	N/A	Flare Traversable LT?	N/A	N/A	Flare	Traversable RT?	N/A
	N/A	Landing Length (in)	N/A	N/A	DWS	Provided?	N/A
	N/A	Landing Width (in)	N/A	N/A	DWS	Contrast?	N/A
	N/A	Landing Slope (%)	N/A	N/A	DWS	Length (in)	N/A
	N/A	Landing X Slope (%)	N/A	N/A	DWS	Full Width?	N/A
	N/A	Landing Curb? (Y/N)	N/A	N/A	DWS	Offset (in)	N/A
	N/A	Shared Landing?	N/A				
	N/A	Gutter Ponding?	N/A	N/A	Gutte	er Slope (%)	N/A
	N/A	Gutter Lip Ht (in)	N/A	N/A	Gutte	er X Slope (%)	N/A
	N/A	Painted X Walk1?	No	N/A	Paint	ed X Walk2?	No
		X Walk 1 Direction	To NE		X Wa	lk 2 Direction	To NW
	N/A	X Walk 1 Width (in)	N/A	N/A	X Wa	lk 2 Width (in)	N/A

X Walk 1 Slope (%)	5.9		X Wa	lk 2 Slope (%)	4.8
		X Walk 1 X Slope (%)	2.8		X Wa	lk 2 X Slope (%)	0.3
	N/A	Ramp inside XWalk1?	N/A	N/A	Ram	o inside XWalk2?	N/A
		Road Slope (%)	3.2	N/A	Clear	Space?	N/A
		Road X Slope (%)	1.6	N/A	Clear	Space to XWalk (in)	N/A
	N/A	Any Obstructions?	N/A	N/A	Storn	n Grate/Utility Hazard?	N/A
		Obstruction Type			Storn	n Grate/Utility Type	
			N/A				N/A
				Yes	Surfa	ce Condition? (G/P)	Good

Possible Solutions: Remove & Replace Curb Ramp With **Two New Directional Ramps or** Equivalent. Surveyor Notes: N/A PROW/ADA: R304.2.2, R304.5.3
