Access Compliance Report

Public Rights-of-Way

(Curb Ramps)

Intersection ID: 10611	Main Street: CLAY_AV	Cross Street: TUCKASEEGEE_RD	Location: S
ADA ID: 6CC99384BDB0	Ramp Type: Perp	Initial Pass/Fail: Fail	Overall Compliance: No
		Severity Score: 12.5

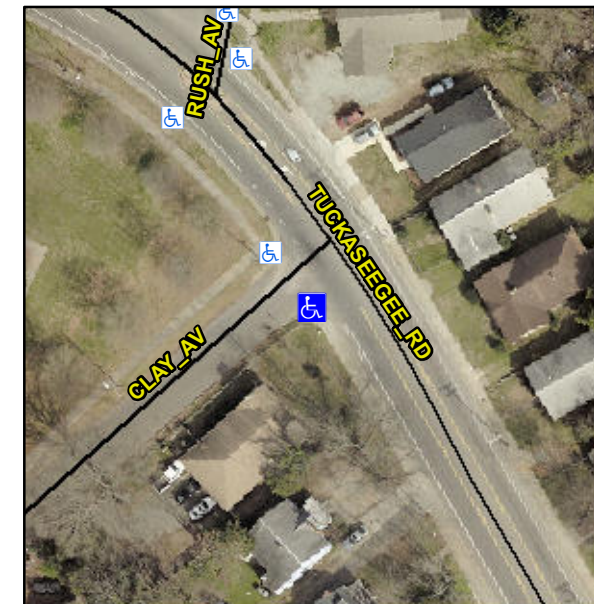
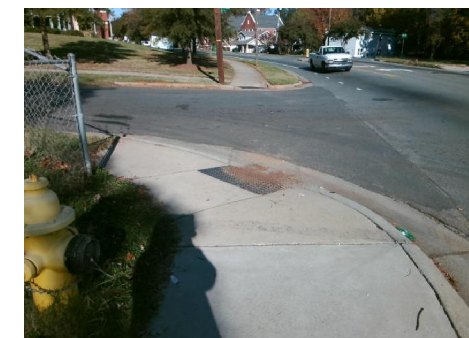
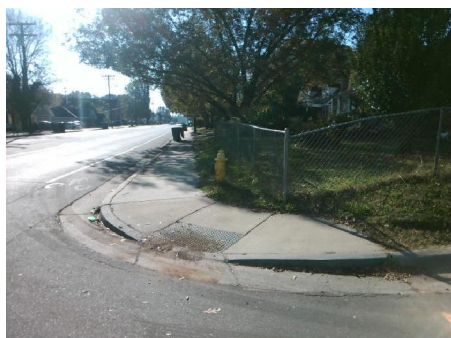
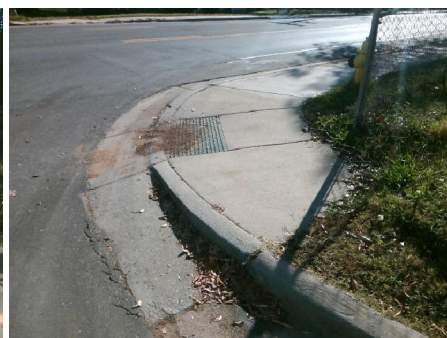
Not Found, R304.2.2

Compliance	Description	Data	Compliance	Description	Data
N/A	Ramp Length (in)	69.0	No	Ramp Slope (%)	10.3
Yes	Ramp Width (in)	48.0	Yes	Ramp XSlope (%)	0.5
N/A	Flare Type LT	N/A	N/A	Flare Type RT	N/A
N/A	Flare Slope LT (%)	N/A	N/A	Flare Slope RT (%)	N/A
N/A	Flare Traversable LT?	N/A	N/A	Flare Traversable RT?	N/A
N/A	Landing Length (in)	N/A	N/A	DWS Provided?	N/A
N/A	Landing Width (in)	N/A	N/A	DWS Contrast?	N/A
N/A	Landing Slope (%)	N/A	N/A	DWS Length (in)	N/A
N/A	Landing X Slope (%)	N/A	N/A	DWS Full Width?	N/A
N/A	Landing Curb? (Y/N)	N/A	N/A	DWS Offset (in)	N/A
N/A	Shared Landing?	N/A			
N/A	Gutter Ponding?	N/A	N/A	Gutter Slope (%)	N/A
N/A	Gutter Lip Ht (in)	N/A	N/A	Gutter X Slope (%)	N/A
N/A	Painted X Walk1?	No	N/A	Painted X Walk2?	N/A
	X Walk 1 Direction	To NW		X Walk 2 Direction	N/A
N/A	X Walk 1 Width (in)	N/A	N/A	X Walk 2 Width (in)	N/A
	X Walk 1 Slope (%)	6.1		X Walk 2 Slope (%)	N/A
	X Walk 1 X Slope (%)	0.3		X Walk 2 X Slope (%)	N/A

Remove & Replace Entire Ramp.
