Access Compliance Report

(Curb Ramps)

| Intersection ID: 18567 | Main Street: MICHAEL_BAKER_PL | Cross Street: RUNNYMEDE_LN | Location: SE |
| ADA ID: 6CCF72D72F8D | Ramp Type: BlendTrans2 | Initial Pass/Fail: Fail | Overall Compliance: No |

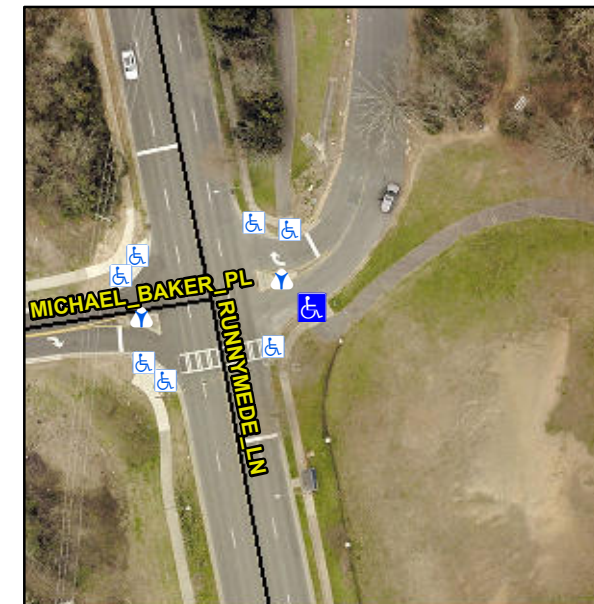
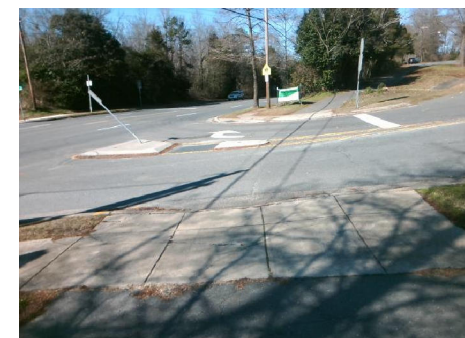
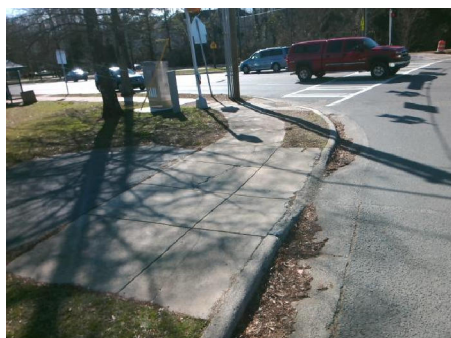
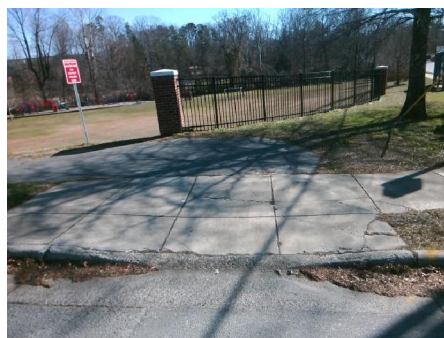
| Severity Score: 21.25 | | | |

Not Found, R304.5.1, R304.5.3

| Compliance | Description | Data | Compliance | Description | Data |
|---|---|---|---|---|---|
| No | Ramp Width (in) | 47.5 | No | BlendTrans XSlope (%) | 6.9 |
| | | | No | Curb Slope (%) | 24.1 |

Remove & Replace Curb Ramp With Two New Directional Ramps or Equivalent.
