Access Compliance Report

Public Rights-of-Way

(Curb Ramps)

Intersection ID: 42795	Main Street: PLUMLEAF_DR	Cross Street: RED_VULCAN_CT	Location: NE
ADA ID: 6CD10C969A63	Ramp Type: PerpDiag	Initial Pass/Fail: Fail	Overall Compliance: No
Severity Score: 22.5			
Codes/Mitigation Info/Possible Solution		Field Measurements/Component Compliance

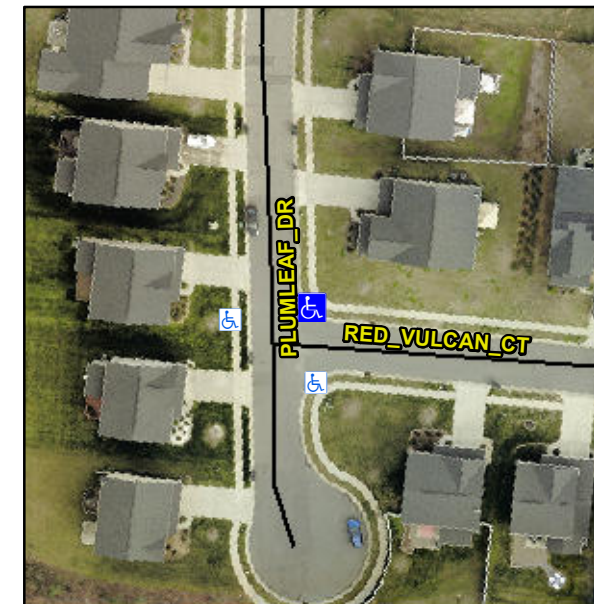
Not Found, R304.5.1, R304.2.2, R304.5.3

Compliance	Description	Data	Compliance	Description	Data
N/A	Ramp Length (in)	48.5	No	Ramp Slope (%)	9.6
No	Ramp Width (in)	47.5	No	Ramp XSlope (%)	4.6
N/A	Flare Type LT	N/A	N/A	Flare Type RT	N/A
N/A	Flare Slope LT (%)	N/A	N/A	Flare Slope RT (%)	N/A
N/A	Flare Traversable LT?	N/A	N/A	Flare Traversable RT?	N/A
N/A	Landing Length (in)	N/A	N/A	DWS Provided?	N/A
N/A	Landing Width (in)	N/A	N/A	DWS Contrast?	N/A
N/A	Landing Slope (%)	N/A	N/A	DWS Length (in)	N/A
N/A	Landing X Slope (%)	N/A	N/A	DWS Full Width?	N/A
N/A	Landing Curb? (Y/N)	N/A	N/A	DWS Offset (in)	N/A
N/A	Shared Landing?	N/A			
N/A	Gutter Ponding?	N/A	N/A	Gutter Slope (%)	N/A
N/A	Gutter Lip Ht (in)	N/A	N/A	Gutter X Slope (%)	N/A
N/A	Painted X Walk1?	No	N/A	Painted X Walk2?	No
	X Walk 1 Direction	To W		X Walk 2 Direction	To S
N/A	X Walk 1 Width (in)	N/A	N/A	X Walk 2 Width (in)	N/A
	X Walk 1 Slope (%)	0.0		X Walk 2 Slope (%)	0.8
	X Walk 1 X Slope (%)	1.8		X Walk 2 X Slope (%)	3.4

N/A	Ramp inside XWalk1?	N/A	N/A	Ramp inside XWalk2?	N/A
	Road Slope (%)	1.9	N/A	Clear Space?	N/A
	Road X Slope (%)	2.7	N/A	Clear Space to XWalk (in)	N/A
N/A	Any Obstructions?	N/A	N/A	Storm Grate/Utility Hazard?	N/A
	Obstruction Type			Storm Grate/Utility Type	
		N/A			N/A
			Yes	Surface Condition? (G/P)	Good

Remove & Replace Curb Ramp With Two New Directional Ramps or Equivalent.
