Intersection ID: 44690	Main Street: SMOOTH_PATH_DR	Cross Street: HARWOOD_HILLS_LN	Location:	NW
ADA ID: 6CD89A77D369	Ramp Type: PerpDiag	Initial Pass/Fail: Fail	Overall Compliance: No	Severity Score: 10

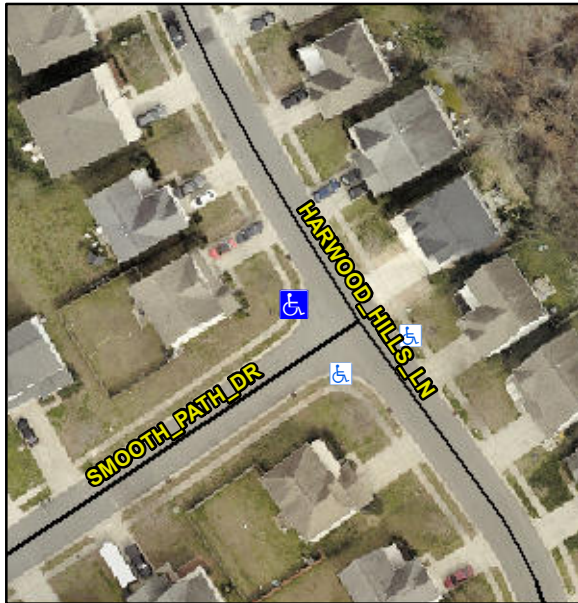
Not Found, R304.5.1, R304.5.3

Compliance	Description	Data	Compliance	Description	Data
N/A	Ramp Length (in)	50.0	Yes	Ramp Slope (%)	5.8
No	Ramp Width (in)	46.5	No	Ramp XSlope (%)	3.9
N/A	Flare Type LT	N/A	N/A	Flare Type RT	N/A
N/A	Flare Slope LT (%)	N/A	N/A	Flare Slope RT (%)	N/A
N/A	Flare Traversable LT?	N/A	N/A	Flare Traversable RT?	N/A
N/A	Landing Length (in)	N/A	N/A	DWS Provided?	N/A
N/A	Landing Width (in)	N/A	N/A	DWS Contrast?	N/A
N/A	Landing Slope (%)	N/A	N/A	DWS Length (in)	N/A
N/A	Landing X Slope (%)	N/A	N/A	DWS Full Width?	N/A
N/A	Landing Curb? (Y/N)	N/A	N/A	DWS Offset (in)	N/A
N/A	Shared Landing?	N/A			
N/A	Gutter Ponding?	N/A	N/A	Gutter Slope (%)	N/A
N/A	Gutter Lip Ht (in)	N/A	N/A	Gutter X Slope (%)	N/A
N/A	Painted X Walk1?	No	N/A	Painted X Walk2?	No
	X Walk 1 Direction	To S		X Walk 2 Direction	To E
N/A	X Walk 1 Width (in)	N/A	N/A	X Walk 2 Width (in)	N/A
	X Walk 1 Slope (%)	3.3		X Walk 2 Slope (%)	4.6
	X Walk 1 X Slope (%)	2.1		X Walk 2 X Slope (%)	4.5

N/A	Ramp inside XWalk1?	N/A	N/A	Ramp inside XWalk2?	N/A
	Road Slope (%)	3.9	N/A	Clear Space?	N/A
	Road X Slope (%)	2.7	N/A	Clear Space to XWalk (in)	N/A
N/A	Any Obstructions?	N/A	N/A	Storm Grate/Utility Hazard?	N/A
	Obstruction Type			Storm Grate/Utility Type	
		N/A			N/A
			Yes	Surface Condition? (G/P)	Good

Remove & Replace Curb Ramp With Two New Directional Ramps or Equivalent.

Total Cost: \$ 3200.00
