Access Compliance Report

Public Rights-of-Way

(Curb Ramps)

Intersection ID: 46821	Main Street: RED_PINE_CT	Cross Street: AZALEA_HILLS_DR	Location:	N
ADA ID: 6CEFD7E454C7	Ramp Type: PerpDiag	Initial Pass/Fail: Fail	Overall Compliance: No	Severity Score: 8.75

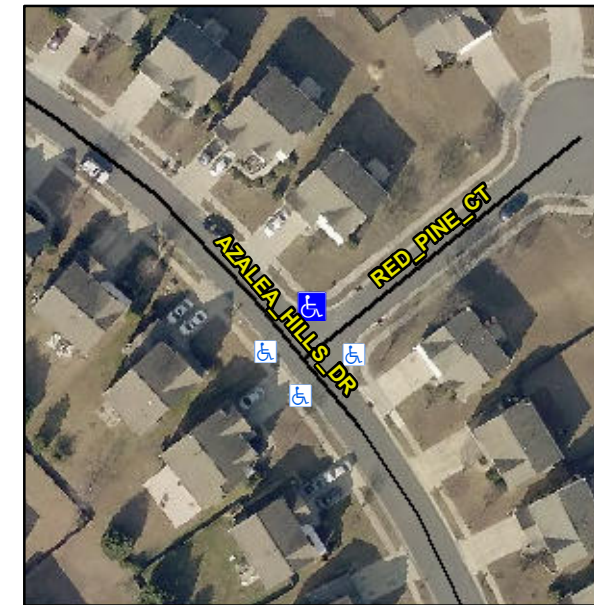
Compliance	Description	Data	Compliance	Description	Data
N/A	Ramp Length (in)	47.0	Yes	Ramp Slope (%)	7.4
No	Ramp Width (in)	43.2	Yes	Ramp XSlope (%)	0.3
N/A	Flare Type LT	N/A	N/A	Flare Type RT	N/A
N/A	Flare Slope LT (%)	N/A	N/A	Flare Slope RT (%)	N/A
N/A	Flare Traversable LT?	N/A	N/A	Flare Traversable RT?	N/A
N/A	Landing Length (in)	N/A	N/A	DWS Provided?	N/A
N/A	Landing Width (in)	N/A	N/A	DWS Contrast?	N/A
N/A	Landing Slope (%)	N/A	N/A	DWS Length (in)	N/A
N/A	Landing X Slope (%)	N/A	N/A	DWS Full Width?	N/A
N/A	Landing Curb? (Y/N)	N/A	N/A	DWS Offset (in)	N/A
N/A	Shared Landing?	N/A			
N/A	Gutter Ponding?	N/A	N/A	Gutter Slope (%)	N/A
N/A	Gutter Lip Ht (in)	N/A	N/A	Gutter X Slope (%)	N/A
N/A	Painted X Walk1?	No	N/A	Painted X Walk2?	No
	X Walk 1 Direction	To SW		X Walk 2 Direction	To SE
N/A	X Walk 1 Width (in)	N/A	N/A	X Walk 2 Width (in)	N/A
	X Walk 1 Slope (%)	0.1		X Walk 2 Slope (%)	0.5
	X Walk 1 X Slope (%)	0.0		X Walk 2 X Slope (%)	0.7

N/A	Ramp inside XWalk1?	N/A	N/A	Ramp inside XWalk2?	N/A
	Road Slope (%)	1.7	N/A	Clear Space?	N/A
	Road X Slope (%)	0.4	N/A	Clear Space to XWalk (in)	N/A
N/A	Any Obstructions?	N/A	N/A	Storm Grate/Utility Hazard?	N/A
	Obstruction Type			Storm Grate/Utility Type	
		N/A			N/A
			Yes	Surface Condition? (G/P)	Good

Remove & Replace Curb Ramp With Two New Directional Ramps or Equivalent.

R304.5.1
