Access Compliance Report

Public Rights-of-Way

(Curb Ramps)

Intersection ID: 53831	Main Street: SHARON_RIDGE_LN	Cross Street: SHARON_ACRES_RD	Location: SE
ADA ID: 6CF0DA405739	Ramp Type: BlendTrans1	Initial Pass/Fail: Fail	Overall Compliance: No
		Severity Score: 10

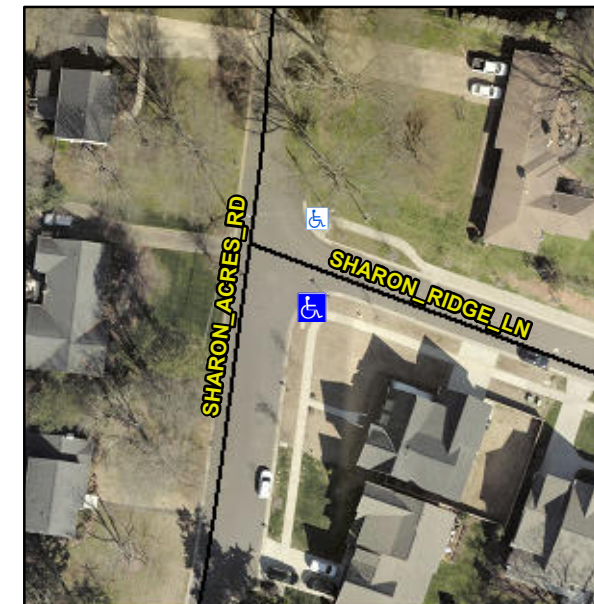
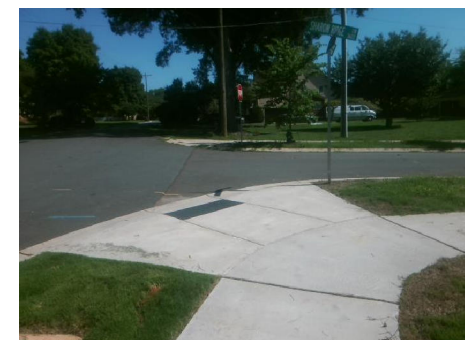
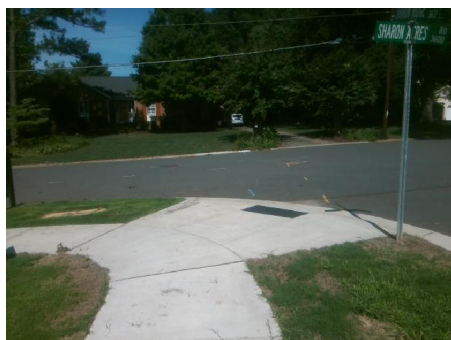
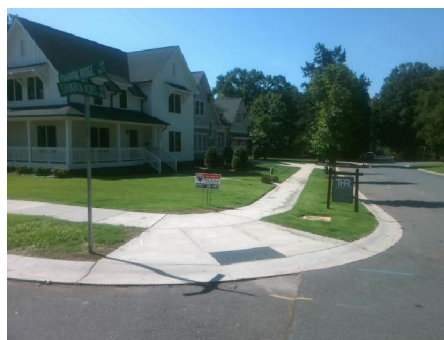
Not Found, R304.5.1, R304.5.3

Compliance	Description	Data	Compliance	Description	Data
N/A	Ramp Length (in)	93.0	Yes	BlendTrans Slope (%)	2.4
No	Ramp Width (in)	47.0	No	BlendTrans XSlope (%)	3.8
N/A	Flare Type LT	N/A	N/A	Flare Type RT	N/A
N/A	Flare Slope LT (%)	N/A	N/A	Flare Slope RT (%)	N/A
N/A	Flare Traversable LT?	N/A	N/A	Flare Traversable RT?	N/A
N/A	Landing Length (in)	N/A	N/A	DWS Provided?	N/A
N/A	Landing Width (in)	N/A	N/A	DWS Contrast?	N/A
N/A	Landing Slope (%)	N/A	N/A	DWS Length (in)	N/A
N/A	Landing X Slope (%)	N/A	N/A	DWS Full Width?	N/A
N/A	Landing Curb? (Y/N)	N/A	N/A	DWS Offset (in)	N/A
N/A	Shared Landing?	N/A			
N/A	Gutter Ponding?	N/A	N/A	Gutter Slope (%)	N/A
N/A	Gutter Lip Ht (in)	1.0	N/A	Gutter X Slope (%)	N/A
N/A	Painted X Walk1?	No	N/A	Painted X Walk2?	No
	X Walk 1 Direction	To N		X Walk 2 Direction	To W
	X Walk 1 Width (in)	N/A		X Walk 2 Width (in)	N/A
	X Walk 1 Slope (%)	5.3		X Walk 2 Slope (%)	3.5
	X Walk 1 X Slope (%)	0.0		X Walk 2 X Slope (%)	6.5

N/A	Ramp inside XWalk1?	N/A	N/A	Ramp inside XWalk2?	N/A
	Road Slope (%)	2.3		Clear Space?	N/A
	Road X Slope (%)	1.9	N/A	Clear Space to XWalk (in)	N/A
N/A	Any Obstructions?	N/A	N/A	Storm Grate/Utility Hazard?	N/A
	Obstruction Type			Storm Grate/Utility Type	
		N/A			N/A
			Yes	Surface Condition? (G/P)	Good
			No	Curb Slope (%)	8.6

Remove & Replace Curb Ramp With Two New Directional Ramps or Equivalent.
