# Access Compliance Report

## Public Rights-of-Way

### (Curb Ramps)

| Intersection ID: 50616 | Main Street: PADDLE_OAK_RD | Cross Street: FAWN_LILY | Location: SW |

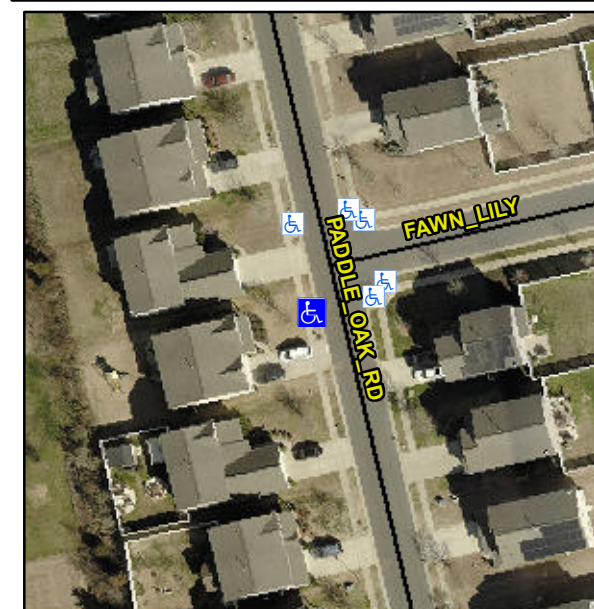
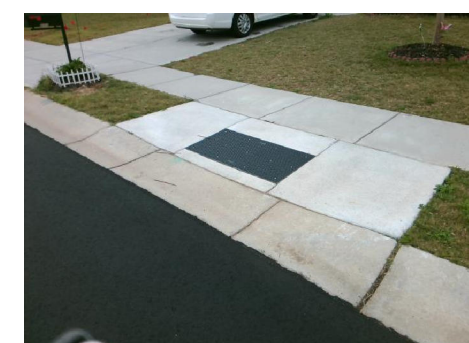
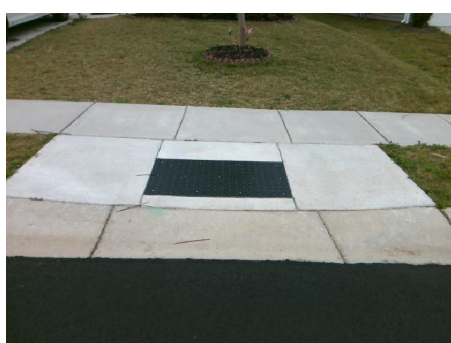
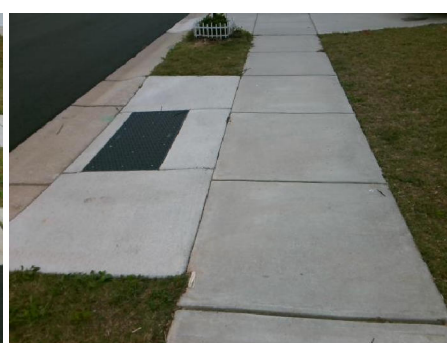
| ADA ID: 6CF2DA160B36 | Ramp Type: Perp | Initial Pass/Fail: Fail | Overall Compliance: No |
| Severity Score: 22.5 | | | |

| Compliance | Description | Data | Compliance | Description | Data |
|---|---|---|---|---|---|
| N/A | Ramp Length (in) | 47.5 | No | Ramp Slope (%) | 9.4 |
| No | Ramp Width (in) | 47.0 | Yes | Ramp XSlope (%) | 2.9 |

**Remove & Replace Entire Ramp.**

**R304.5.1, R304.2.2**

Total Cost: \$ 1850.00
