Access Compliance Report

Public Rights-of-Way

(Curb Ramps)

Intersection ID: 4850	Main Street: HARRINGTON_WOODS_RD	Cross Street: W_W_T_HARRIS_BV	Location: W
ADA ID: 6CF863D72CC4	Ramp Type: Perp	Initial Pass/Fail: Fail	Overall Compliance: No
Severity Score: 26.25			
Codes/Mitigation Info/Possible Solution		Field Measurements/Component Compliance

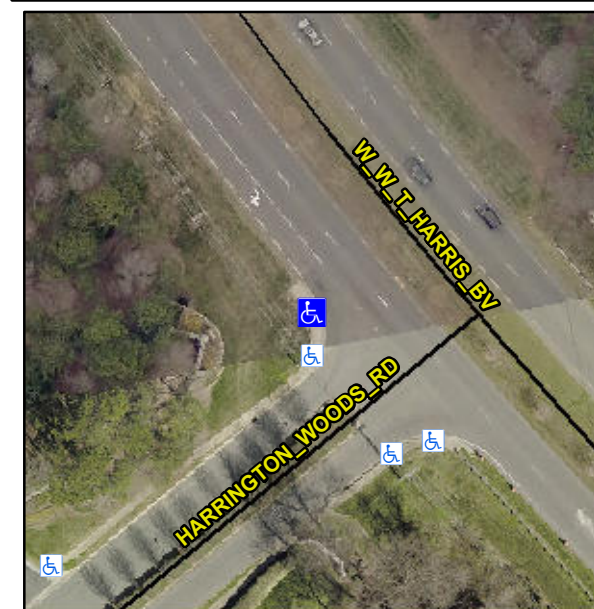
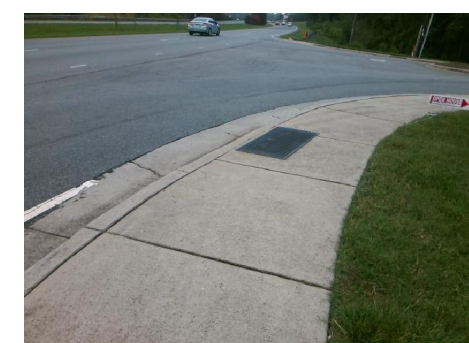
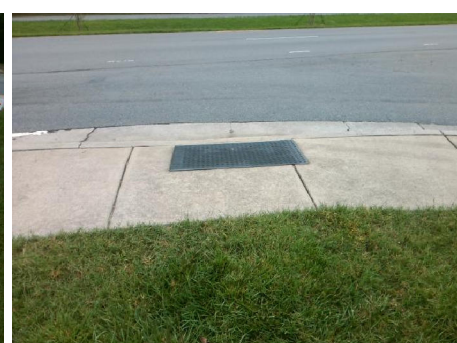
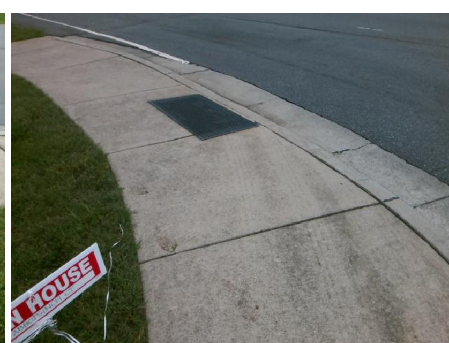
Compliance	Description	Data	Compliance	Description	Data
N/A	Ramp Length (in)	59.5	No	Ramp Slope (%)	20.0
Yes	Ramp Width (in)	48.0	No	Ramp XSlope (%)	4.7
N/A	Flare Type LT	N/A	N/A	Flare Type RT	N/A
N/A	Flare Slope LT (%)	N/A	N/A	Flare Slope RT (%)	N/A
N/A	Flare Traversable LT?	N/A	N/A	Flare Traversable RT?	N/A
N/A	Landing Length (in)	N/A	N/A	DWS Provided?	N/A
N/A	Landing Width (in)	N/A	N/A	DWS Contrast?	N/A
N/A	Landing Slope (%)	N/A	N/A	DWS Length (in)	N/A
N/A	Landing X Slope (%)	N/A	N/A	DWS Full Width?	N/A
N/A	Landing Curb? (Y/N)	N/A	N/A	DWS Offset (in)	N/A
N/A	Shared Landing?	N/A			
N/A	Gutter Ponding?	N/A	N/A	Gutter Slope (%)	N/A
N/A	Gutter Lip Ht (in)	N/A	N/A	Gutter X Slope (%)	N/A
N/A	Painted X Walk1?	No	N/A	Painted X Walk2?	N/A
	X Walk 1 Direction	To E		X Walk 2 Direction	N/A
N/A	X Walk 1 Width (in)	N/A	N/A	X Walk 2 Width (in)	N/A
	X Walk 1 Slope (%)	1.0		X Walk 2 Slope (%)	N/A
	X Walk 1 X Slope (%)	3.9		X Walk 2 X Slope (%)	N/A

N/A	Ramp inside XWalk1?	N/A	N/A	Ramp inside XWalk2?	N/A
	Road Slope (%)	N/A	N/A	Clear Space?	N/A
	Road X Slope (%)	N/A	N/A	Clear Space to XWalk (in)	N/A
N/A	Any Obstructions?	N/A	N/A	Storm Grate/Utility Hazard?	N/A
	Obstruction Type			Storm Grate/Utility Type	
		N/A			N/A
			Yes	Surface Condition? (G/P)	Good

Remove & Replace Entire Ramp.

R304.2.2, R304.5.3
