Access Compliance Report Public Rights-of-Way (Curb Ramps)

Intersection ID: 49946 Main Street: OPEN_BOOK_LN Cross Street: KUYKENDALL_RD Location: SW

ADA ID: 6CFA704176C3 Ramp Type: BlendTrans1 Initial Pass/Fail: Fail Overall Compliance: No Severity Score: 1.25

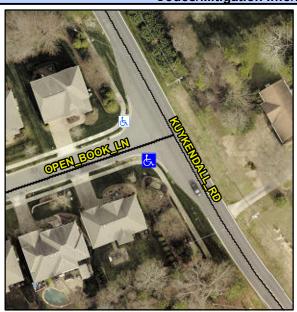
Not Found, R304.5.3

Field Measurements/Component Compliance					
Comp	liance Description	Data	Comp	liance Description	Data
N/A	Ramp Length (in)	37.0	Yes	BlendTrans Slope (%)	3.6
Yes	Ramp Width (in)	48.0	No	BlendTrans XSlope (%)	3.0
N/A	Flare Type LT	N/A	N/A	Flare Type RT	N/A
N/A	Flare Slope LT (%)	N/A	N/A	Flare Slope RT (%)	N/A
N/A	Flare Traversable LT?	N/A	N/A	Flare Traversable RT?	N/A
N/A	Landing Length (in)	N/A	N/A	DWS Provided?	N/A
N/A	Landing Width (in)	N/A	N/A	DWS Contrast?	N/A
N/A	Landing Slope (%)	N/A	N/A	DWS Length (in)	N/A
N/A	Landing X Slope (%)	N/A	N/A	DWS Full Width?	N/A
N/A	Landing Curb? (Y/N)	N/A	N/A	DWS Offset (in)	N/A
N/A	Shared Landing?	N/A			
N/A	Gutter Ponding?	N/A	N/A	Gutter Slope (%)	N/A
N/A	Gutter Lip Ht (in)	N/A	N/A	Gutter X Slope (%)	N/A
N/A	Painted X Walk1?	No	N/A	Painted X Walk2?	N/A
	X Walk 1 Direction	To NW		X Walk 2 Direction	N/A
	X Walk 1 Width (in)	N/A		X Walk 2 Width (in)	N/A
	X Walk 1 Slope (%)	1.0		X Walk 2 Slope (%)	N/A

X Walk 1 X Slope (%)	2.3		X Walk 2 X Slope (%)	N/A
N/A	Ramp inside XWalk1?	N/A	N/A	Ramp inside XWalk2?	N/A
	Road Slope (%)	2.3		Clear Space?	N/A
	Road X Slope (%)	1.0	N/A	Clear Space to XWalk (in)	N/A
N/A	Any Obstructions?	N/A	N/A	Storm Grate/Utility Hazard?	N/A
	Obstruction Type			Storm Grate/Utility Type	
		N/A			N/A
			Yes	Surface Condition? (G/P)	Good
1 11	A SHARE S		No	Curb Slope (%)	12.2
A

Remove & Replace Curb Ramp With Two New Directional Ramps or Equivalent.

3200.00
