# Access Compliance Report

## Public Rights-of-Way

### (Curb Ramps)

| Intersection ID: 11986 | Main Street: AMITY_CT | Cross Street: N_SHARON_AMITY_RD | Location: SE |

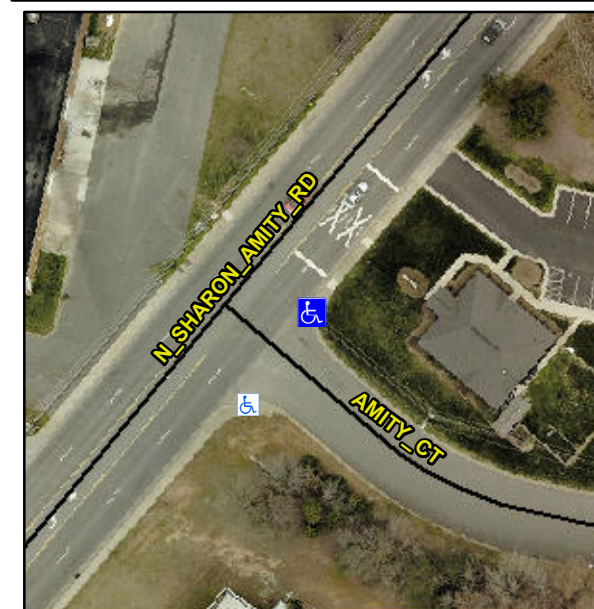
| ADA ID: 6D05612DFCD1 | Ramp Type: Perp | Initial Pass/Fail: Fail | Overall Compliance: No |
| Severity Score: 33.75 | | | |

**Not Found, R304.5.1, R304.2.2, R304.5.3**

| Compliance | Description | Data | Compliance | Description | Data |
|---|---|---|---|---|---|
| N/A | Ramp Length (in) | 59.0 | No | Ramp Slope (%) | 11.0 |
| No | Ramp Width (in) | 42.0 | No | Ramp XSlope (%) | 5.9 |

**Remove & Replace Entire Ramp.**

Total Cost: \$ 1850.00
