Access Compliance Report

Public Rights-of-Way

(Curb Ramps)

Intersection ID: 23459	Main Street: ALEXANDER_RD	Cross Street: GARDNER_LN	Location: NW
ADA ID: 6D08CDA905A9	Ramp Type: BlendTrans1	Initial Pass/Fail: Fail	Overall Compliance: No
Severity Score: 1.25			
Codes/Mitigation Info/Possible Solution		Field Measurements/Component Compliance

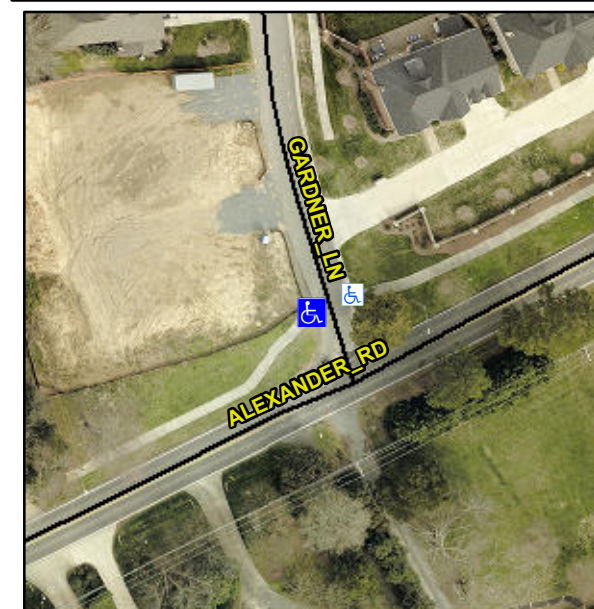
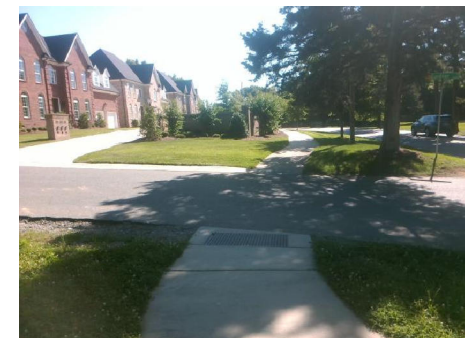
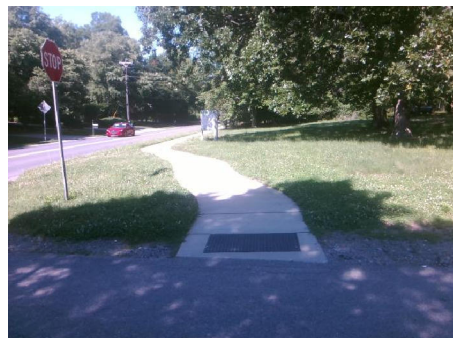
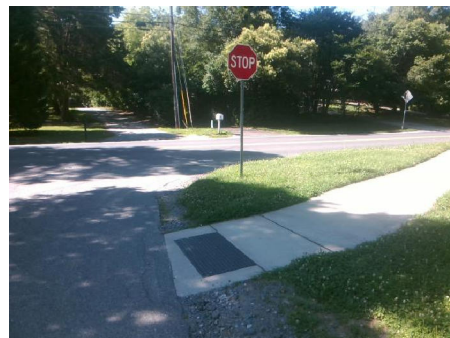
Compliance	Description	Data	Compliance	Description	Data
N/A	Ramp Length (in)	54.0	Yes	BlendTrans Slope (%)	2.8
Yes	Ramp Width (in)	72.0	No	BlendTrans XSlope (%)	4.0
N/A	Flare Type LT	N/A	N/A	Flare Type RT	N/A
N/A	Flare Slope LT (%)	N/A	N/A	Flare Slope RT (%)	N/A
N/A	Flare Traversable LT?	N/A	N/A	Flare Traversable RT?	N/A
N/A	Landing Length (in)	N/A	N/A	DWS Provided?	N/A
N/A	Landing Width (in)	N/A	N/A	DWS Contrast?	N/A
N/A	Landing Slope (%)	N/A	N/A	DWS Length (in)	N/A
N/A	Landing X Slope (%)	N/A	N/A	DWS Full Width?	N/A
N/A	Landing Curb? (Y/N)	N/A	N/A	DWS Offset (in)	N/A
N/A	Shared Landing?	N/A			
N/A	Gutter Ponding?	N/A	N/A	Gutter Slope (%)	N/A
N/A	Gutter Lip Ht (in)	N/A	N/A	Gutter X Slope (%)	N/A
N/A	Painted X Walk1?	No	N/A	Painted X Walk2?	N/A
	X Walk 1 Direction	To NE		X Walk 2 Direction	N/A
	X Walk 1 Width (in)	N/A		X Walk 2 Width (in)	N/A
	X Walk 1 Slope (%)	4.4		X Walk 2 Slope (%)	N/A
	X Walk 1 X Slope (%)	4.5		X Walk 2 X Slope (%)	N/A

N/A	Ramp inside XWalk1?	N/A	N/A	Ramp inside XWalk2?	N/A
	Road Slope (%)	4.5		Clear Space?	N/A
	Road X Slope (%)	4.4	N/A	Clear Space to XWalk (in)	N/A
N/A	Any Obstructions?	N/A	N/A	Storm Grate/Utility Hazard?	N/A
	Obstruction Type			Storm Grate/Utility Type	
		N/A			N/A
			Yes	Surface Condition? (G/P)	Good
			N/A	Curb Slope (%)	2.2

Possible Solutions:

Remove & Replace Curb Ramp With Two New Directional Ramps or Equivalent.
