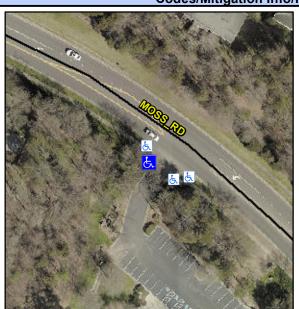
Intersection ID: 10032240 Main Street: MOSS_RD Cross Street: N/A Location: SW ADA ID: 6D0909F82049 Ramp Type: Perp Initial Pass/Fail: Fail **Overall Compliance: No Severity Score:** 27.5

Field Measurements/Component Compliance								
Compl	iance Description	Data	Comp	liance	Description	Data		
N/A	Ramp Length (in)	122.0	No	Ramp	Slope (%)	9.3		
Yes	Ramp Width (in)	48.0	Yes	Ramp	XSlope (%)	1.6		
N/A	Flare Type LT	N/A	N/A	Flare	Type RT	N/A		
N/A	Flare Slope LT (%)	N/A	N/A	Flare	Slope RT (%)	N/A		
N/A	Flare Traversable LT?	N/A	N/A	Flare	Traversable RT?	N/A		
N/A	Landing Length (in)	N/A	N/A	DWS	Provided?	N/A		
N/A	Landing Width (in)	N/A	N/A	DWS	Contrast?	N/A		
N/A	Landing Slope (%)	N/A	N/A	DWS	Length (in)	N/A		
N/A	Landing X Slope (%)	N/A	N/A	DWS	Full Width?	N/A		
N/A	Landing Curb? (Y/N)	N/A	N/A	DWS	Offset (in)	N/A		
N/A	Shared Landing?	N/A						
N/A	Gutter Ponding?	N/A	N/A	Gutte	r Slope (%)	N/A		
N/A	Gutter Lip Ht (in)	N/A	N/A	Gutte	r X Slope (%)	N/A		
N/A	Painted X Walk1?	No	N/A	Painte	ed X Walk2?	N/A		
	X Walk 1 Direction	To SE		X Wa	lk 2 Direction	N/A		
N/A	X Walk 1 Width (in)	N/A	N/A	X Wa	lk 2 Width (in)	N/A

X Walk 1 Slope (%)	3.4		X Wa	lk 2 Slope (%)	N/A		
	X Walk 1 X Slope (%)	0.0		X Wa	lk 2 X Slope (%)	N/A		
N/A	Ramp inside XWalk1?	N/A	N/A	Ramp	inside XWalk2?	N/A		
	Road Slope (%)	N/A	N/A	Clear	Space?	N/A		
	Road X Slope (%)	N/A	N/A	Clear	Space to XWalk (in)	N/A		
N/A	Any Obstructions?	N/A	N/A	Storm	Grate/Utility Hazard?	N/A		
	Obstruction Type			Storm	Grate/Utility Type			
		N/A				N/A		
			No	Surfa	ce Condition? (G/P)	Poor

T CCCIDIC CCIALICIT			
Possible Solutions:	<u>C</u>		
Remove & Replace Entire Ramp.			
	Ye		
	N/		
Surveyor Notes:	N/		
N/A	N/		
	N/		
	N/		
	N/		
PROW/ADA:	N/		
Not Found, R304.2.2, R302.7	N/		
	N/		
	N/

Total Cost:

1850.00
