## Access Compliance Report Public Rights-of-Way (Curb Ramps)

Intersection ID: 3978Main Street: AMBLESIDE\_DRCross Street: WOODFORD\_BRIDGE\_DRLocation:EADA ID: 6D2437775265Ramp Type: BlendTrans1Initial Pass/Fail: PassOverall Compliance: NoSeverity Score:0

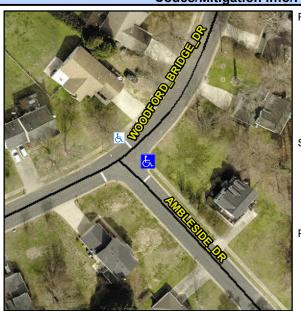
GTR GAP 2.0

Not Found, R304.2.2-Perp, R304.3.2-Para

Field Measurements/Component Compliance					
Compliance Description		Data	Compliance Description		Data
N/A	Ramp Length (in)	24.5	Yes	BlendTrans Slope (%)	2.8
Yes	Ramp Width (in)	48.0	Yes	BlendTrans XSlope (%)	0.0
N/A	Flare Type LT	Sloped	N/A	Flare Type RT	Sloped
N/A	Flare Slope LT (%)	2.7	N/A	Flare Slope RT (%)	1.8
N/A	Flare Traversable LT?	No	N/A	Flare Traversable RT?	No
Yes	Landing Length (in)	51.0	Yes	DWS Provided?	Yes
Yes	Landing Width (in)	48.0	Yes	DWS Contrast?	Yes
No	Landing Slope (%)	3.6	Yes	DWS Length (in)	24.5
Yes	Landing X Slope (%)	1.0	Yes	DWS Full Width?	Yes
N/A	Landing Curb? (Y/N)	No	Yes	DWS Offset (in)	0.0
N/A	Shared Landing?	No			
Yes	Gutter Ponding?	No	Yes	Gutter Slope (%)	4.5
Yes	Gutter Lip Ht (in)	0.0	Yes	Gutter X Slope (%)	0.5
N/A	Painted X Walk1?	No	N/A	Painted X Walk2?	N/A
	X Walk 1 Direction	To NW		X Walk 2 Direction	N/A
	X Walk 1 Width (in)	N/A		X Walk 2 Width (in)	N/A
	X Walk 1 Slope (%)	1.3		X Walk 2 Slope (%)	N/A

X Walk 1 X Slope (%)	1.5		X Walk 2 X Slope (%)	N/A
N/A	Ramp inside XWalk1?	N/A	N/A	Ramp inside XWalk2?	N/A
	Road Slope (%)	1.5		Clear Space?	Yes
	Road X Slope (%)	1.3	N/A	Clear Space to XWalk (in)	N/A
Yes	Any Obstructions?	No	Yes	Storm Grate/Utility Hazard?	No
	Obstruction Type		l	Storm Grate/Utility Type	
		N/A	l		N/A
			Yes	Surface Condition? (G/P)	Good

Remove & Replace Curb Ramp With Two New Directional Ramps or Equivalent.
