# Access Compliance Report

## Public Rights-of-Way

### (Curb Ramps)

| Intersection ID: 47616 | Main Street: TWISTED_PINE_DR | Cross Street: CANIPE_DR | Location: S |

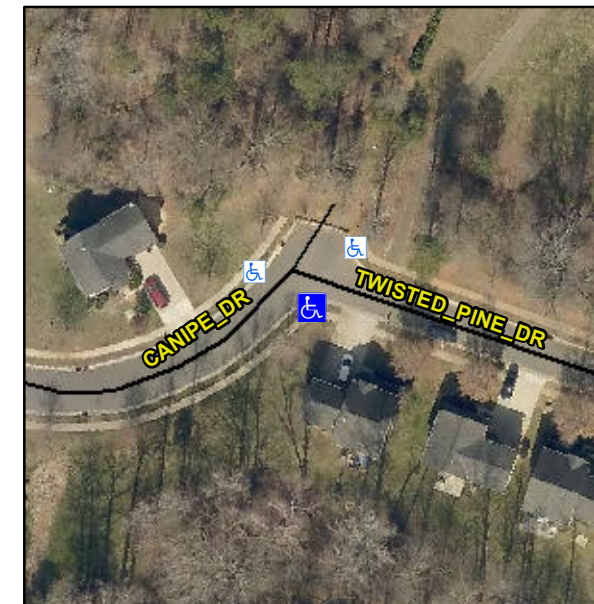
| ADA ID: 6D24E6C6601E | Ramp Type: PerpDiag | Initial Pass/Fail: Fail | Overall Compliance: No |
| | | Severity Score: 12.5 | |

| Compliance | Description | Data | Compliance | Description | Data |
|---|---|---|---|---|---|
| N/A | Ramp Length (in) | 47.0 | No | Ramp Slope (%) | 10.5 |

**Remove & Replace Curb Ramp With Two New Directional Ramps or Equivalent.**

**R304.2.2**

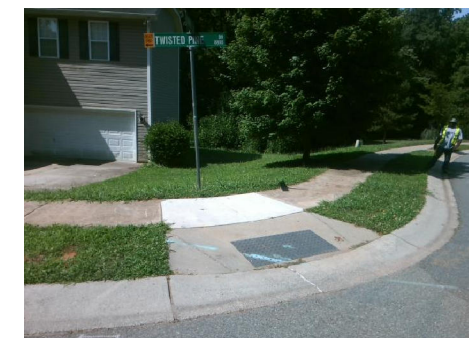
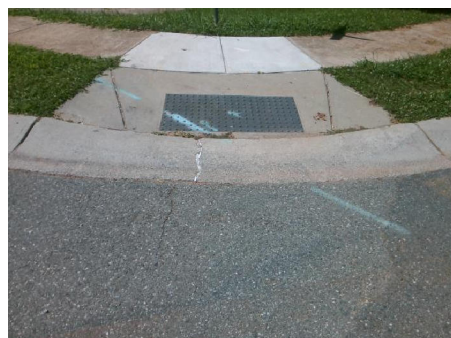
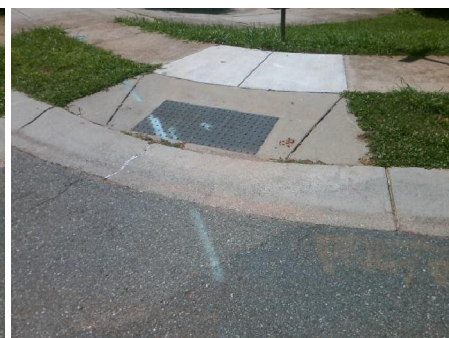
Street 1 Name **TWISTED PINE DR**  
 Stop Condition-Street 2 **StopSign**  
 Street 2 Name **CANIPE DR**  
 Stop Condition-Street 1 **None**
