# Access Compliance Report

## Public Rights-of-Way

### (Curb Ramps)

Intersection ID: 6998	Main Street: NEVIN_RD	Cross Street: STATESVILLE_RD	Location: NW
ADA ID: 6D2AC22F73EC	Ramp Type: Perp	Initial Pass/Fail: Fail	Overall Compliance: No
Severity Score: 21.25			
Codes/Mitigation Info/Possible Solution		Field Measurements/Component Compliance

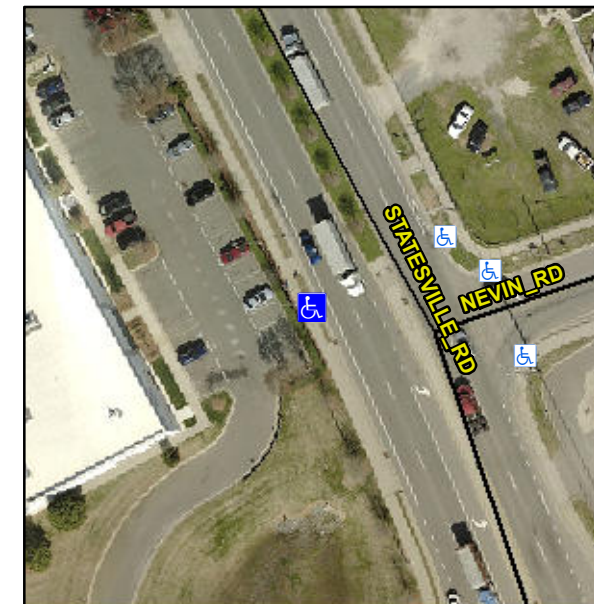
**R304.5.1, R304.2.2**

Compliance	Description	Data	Compliance	Description	Data
N/A	Ramp Length (in)	74.0	No	Ramp Slope (%)	9.8
No	Ramp Width (in)	47.0	Yes	Ramp XSlope (%)	0.5
N/A	Flare Type LT	N/A	N/A	Flare Type RT	N/A
N/A	Flare Slope LT (%)	N/A	N/A	Flare Slope RT (%)	N/A
N/A	Flare Traversable LT?	N/A	N/A	Flare Traversable RT?	N/A
N/A	Landing Length (in)	N/A	N/A	DWS Provided?	N/A
N/A	Landing Width (in)	N/A	N/A	DWS Contrast?	N/A
N/A	Landing Slope (%)	N/A	N/A	DWS Length (in)	N/A
N/A	Landing X Slope (%)	N/A	N/A	DWS Full Width?	N/A
N/A	Landing Curb? (Y/N)	N/A	N/A	DWS Offset (in)	N/A
N/A	Shared Landing?	N/A			
N/A	Gutter Ponding?	N/A	N/A	Gutter Slope (%)	N/A
N/A	Gutter Lip Ht (in)	N/A	N/A	Gutter X Slope (%)	N/A
N/A	Painted X Walk1?	No	N/A	Painted X Walk2?	N/A
	X Walk 1 Direction	To E		X Walk 2 Direction	N/A
N/A	X Walk 1 Width (in)	N/A	N/A	X Walk 2 Width (in)	N/A
	X Walk 1 Slope (%)	3.1		X Walk 2 Slope (%)	N/A
	X Walk 1 X Slope (%)	0.1		X Walk 2 X Slope (%)	N/A

N/A	Ramp inside XWalk1?	N/A	N/A	Ramp inside XWalk2?	N/A
	Road Slope (%)	N/A	N/A	Clear Space?	N/A
	Road X Slope (%)	N/A	N/A	Clear Space to XWalk (in)	N/A
N/A	Any Obstructions?	N/A	N/A	Storm Grate/Utility Hazard?	N/A
	Obstruction Type			Storm Grate/Utility Type	
		N/A			N/A
			Yes	Surface Condition? (G/P)	Good

**Remove & Replace Entire Ramp.**
