Access Compliance Report Public Rights-of-Way (Curb Ramps)

Intersection ID: 4731Main Street: ARKLOW_RDCross Street: HARRINGTON_WOODS_RDLocation:SEADA ID: 6D2C4113462FRamp Type: PerpInitial Pass/Fail: FailOverall Compliance: NoSeverity Score:25

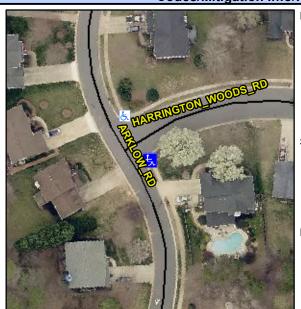
i ossibic ociation			ricia measarements/component compnance					
Possible Solutions:			Compliance Description		Data	Data Compliance Description		
Remove & Replace Entire	Ram	p.	N/A	Ramp Length (in)	39.0	No	Ramp Slope (%)

•		•	Yes	Ramp Width (in)	48.0	Yes	Ramp XSlope (%)	
			N/A	Flare Type LT	N/A	N/A	Flare Type RT	
			N/A	Flare Slope LT (%)	N/A	N/A	Flare Slope RT (%)	
			N/A	Flare Traversable LT?	N/A	N/A	Flare Traversable RT?	
			N/A	Landing Length (in)	N/A	N/A	DWS Provided?	
Surveyor Notes:			N/A	Landing Width (in)	N/A	N/A	DWS Contrast?	
N/A			N/A	Landing Slope (%)	N/A	N/A	DWS Length (in)	
			N/A	Landing X Slope (%)	N/A	N/A	DWS Full Width?	
			N/A	Landing Curb? (Y/N)	N/A	N/A	DWS Offset (in)	
			N/A	Shared Landing?	N/A			
PROW/ADA:			N/A	Gutter Ponding?	N/A	N/A	Gutter Slope (%)	
Not Found, R304.2.2			N/A	Gutter Lip Ht (in)	N/A	N/A	Gutter X Slope (%)	
·			N/A	Painted X Walk1?	No	N/A	Painted X Walk2?	
				X Walk 1 Direction	To N		X Walk 2 Direction	
			N/A	X Walk 1 Width (in)	N/A	N/A	X Walk 2 Width (in)	
				X Walk 1 Slope (%)	4.3		X Walk 2 Slope (%)	
				X Walk 1 X Slope (%)	5.3		X Walk 2 X Slope (%)	
			N/A	Ramp inside XWalk1?	N/A	N/A	Ramp inside XWalk2?

Road Slope (%)	N/A	N/A	Clear Space?	
				Road X Slope (%)	N/A	N/A	Clear Space to XWalk (in)	
			N/A	Any Obstructions?	N/A	N/A	Storm Grate/Utility Hazard?	
Total Cost:	\$	1850.00		Obstruction Type			Storm Grate/Utility Type	
					N/A
