# Access Compliance Report

## Public Rights-of-Way

### (Curb Ramps)

Intersection ID: 11894	Main Street: N_BREVARD_ST	Cross Street: E_12TH_ST	Location: N
ADA ID: 6D3B732824ED	Ramp Type: Perp	Initial Pass/Fail: Fail	Overall Compliance: No
Severity Score: 8.75			
Codes/Mitigation Info/Possible Solution		Field Measurements/Component Compliance

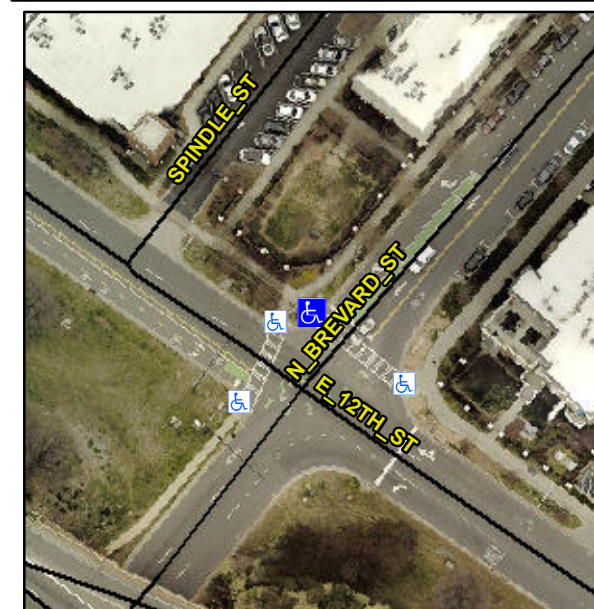
**Not Found, R304.5.1**

Compliance	Description	Data	Compliance	Description	Data
N/A	Ramp Length (in)	72.0	Yes	Ramp Slope (%)	7.7
No	Ramp Width (in)	47.5	Yes	Ramp XSlope (%)	0.6
N/A	Flare Type LT	N/A	N/A	Flare Type RT	N/A
N/A	Flare Slope LT (%)	N/A	N/A	Flare Slope RT (%)	N/A
N/A	Flare Traversable LT?	N/A	N/A	Flare Traversable RT?	N/A
N/A	Landing Length (in)	N/A	N/A	DWS Provided?	N/A
N/A	Landing Width (in)	N/A	N/A	DWS Contrast?	N/A
N/A	Landing Slope (%)	N/A	N/A	DWS Length (in)	N/A
N/A	Landing X Slope (%)	N/A	N/A	DWS Full Width?	N/A
N/A	Landing Curb? (Y/N)	N/A	N/A	DWS Offset (in)	N/A
N/A	Shared Landing?	N/A			
N/A	Gutter Ponding?	N/A	N/A	Gutter Slope (%)	N/A
N/A	Gutter Lip Ht (in)	N/A	N/A	Gutter X Slope (%)	N/A
N/A	Painted X Walk1?	Yes	N/A	Painted X Walk2?	N/A
	X Walk 1 Direction	To SE		X Walk 2 Direction	N/A
N/A	X Walk 1 Width (in)	87.0	N/A	X Walk 2 Width (in)	N/A
	X Walk 1 Slope (%)	2.6		X Walk 2 Slope (%)	N/A
	X Walk 1 X Slope (%)	1.8		X Walk 2 X Slope (%)	N/A

N/A	Ramp inside XWalk1?	Yes	N/A	Ramp inside XWalk2?	N/A
	Road Slope (%)	N/A	N/A	Clear Space?	N/A
	Road X Slope (%)	N/A	N/A	Clear Space to XWalk (in)	N/A
N/A	Any Obstructions?	N/A	N/A	Storm Grate/Utility Hazard?	N/A
	Obstruction Type			Storm Grate/Utility Type	
		N/A			N/A
		Yes		Surface Condition? (G/P)	Good

**Remove & Replace Entire Ramp.**
