Access Compliance Report

Public Rights-of-Way

(Curb Ramps)

Intersection ID: 18554	Main Street: HEATHMOOR_LN	Cross Street: SHARON_LN	Location: E
ADA ID: 6D45DEB3D077	Ramp Type: Perp	Initial Pass/Fail: Fail	Overall Compliance: No
		Severity Score: 17.5

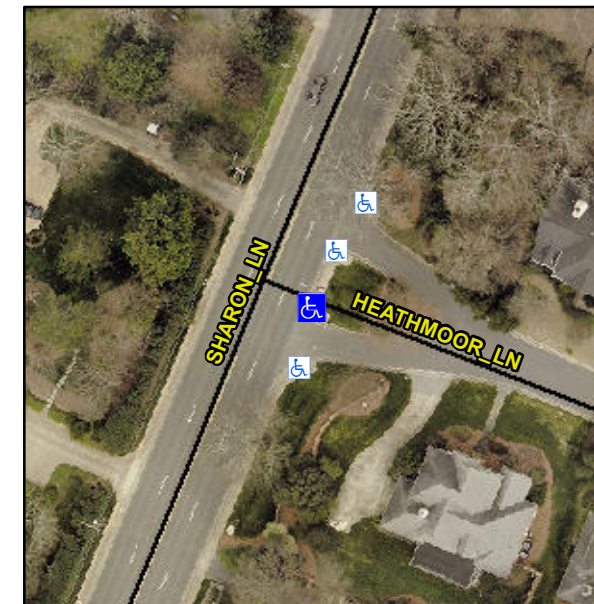
Not Found, R304.5.1

Compliance	Description	Data	Compliance	Description	Data
N/A	Ramp Length (in)	65.0	Yes	Ramp Slope (%)	6.0
No	Ramp Width (in)	32.5	Yes	Ramp XSlope (%)	0.8
N/A	Flare Type LT	N/A	N/A	Flare Type RT	N/A
N/A	Flare Slope LT (%)	N/A	N/A	Flare Slope RT (%)	N/A
N/A	Flare Traversable LT?	N/A	N/A	Flare Traversable RT?	N/A
N/A	Landing Length (in)	N/A	N/A	DWS Provided?	N/A
N/A	Landing Width (in)	N/A	N/A	DWS Contrast?	N/A
N/A	Landing Slope (%)	N/A	N/A	DWS Length (in)	N/A
N/A	Landing X Slope (%)	N/A	N/A	DWS Full Width?	N/A
N/A	Landing Curb? (Y/N)	N/A	N/A	DWS Offset (in)	N/A
N/A	Shared Landing?	N/A			
N/A	Gutter Ponding?	N/A	N/A	Gutter Slope (%)	N/A
N/A	Gutter Lip Ht (in)	N/A	N/A	Gutter X Slope (%)	N/A
N/A	Painted X Walk1?	No	N/A	Painted X Walk2?	N/A
	X Walk 1 Direction	To SW		X Walk 2 Direction	N/A
N/A	X Walk 1 Width (in)	N/A	N/A	X Walk 2 Width (in)	N/A
	X Walk 1 Slope (%)	0.1		X Walk 2 Slope (%)	N/A
	X Walk 1 X Slope (%)	3.3		X Walk 2 X Slope (%)	N/A

N/A	Ramp inside XWalk1?	N/A	N/A	Ramp inside XWalk2?	N/A
	Road Slope (%)	N/A	N/A	Clear Space?	N/A
	Road X Slope (%)	N/A	N/A	Clear Space to XWalk (in)	N/A
N/A	Any Obstructions?	N/A	N/A	Storm Grate/Utility Hazard?	N/A
	Obstruction Type			Storm Grate/Utility Type	
		N/A			N/A
			Yes	Surface Condition? (G/P)	Good

Possible Solutions:

Remove & Replace Entire Ramp.
