# Access Compliance Report

## Public Rights-of-Way

### (Curb Ramps)

Intersection ID: N/A	Main Street: SPEER_BV	Cross Street: ZILKER_PARK_DR	Location: N
ADA ID: 6D46CEBAF87B	Ramp Type: Directional1	Initial Pass/Fail: Fail	Overall Compliance: No
		Severity Score: 1.25

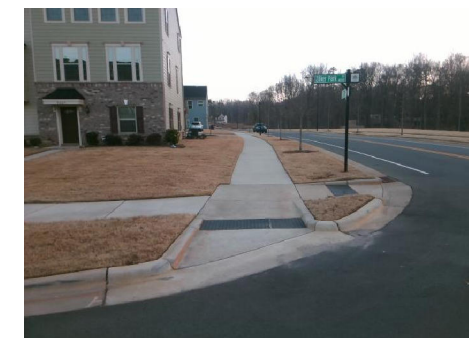
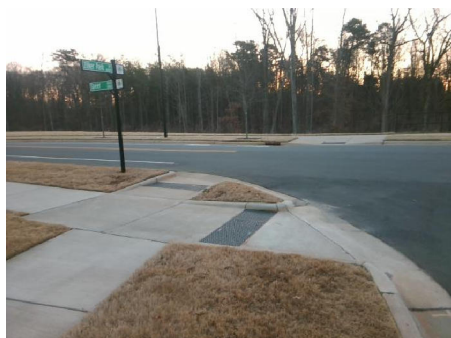
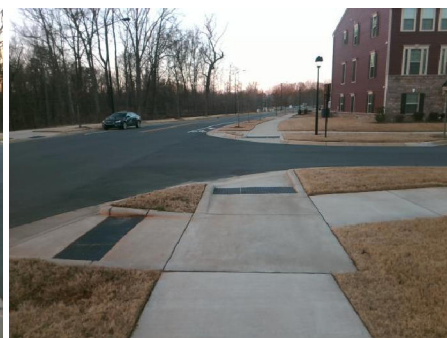
Compliance	Description	Data	Compliance	Description	Data
N/A	Ramp Length (in)	78.0	N/A	Grade Break?	N/A
Yes	Ramp Width (in)	70.0	N/A	Grade Break Slope (%)	0.0
Yes	Ramp Slope (%)	1.9	N/A	Grade Break XSlope (%)	0.0
No	Ramp XSlope (%)	2.5			
N/A	Flare Type LT	N/A	N/A	Flare Type RT	N/A
N/A	Flare Slope LT (%)	N/A	N/A	Flare Slope RT (%)	0.0
N/A	Flare Traversable LT?	N/A	N/A	Flare Traversable RT?	N/A
N/A	Landing Length (in)	0.0	N/A	DWS Provided?	N/A
N/A	Landing Width (in)	0.0	N/A	DWS Contrast?	N/A
N/A	Landing Slope (%)	0.0	N/A	DWS Length (in)	N/A
N/A	Landing X Slope (%)	0.0	N/A	DWS Full Width?	N/A
N/A	Landing Curb? (Y/N)	N/A	N/A	DWS Offset LT (in)	N/A
N/A	Shared Landing?	N/A	N/A	DWS Offset RT (in)	N/A
N/A	Gutter Ponding?	0.0	N/A	Gutter Slope (%)	N/A
N/A	Gutter Lip Ht (in)	0.0	N/A	Gutter X Slope (%)	N/A
N/A	Painted X Walk1?	No		Road Slope (%)	0.7
	X Walk 1 Direction	To SW		Road X Slope (%)	1.4
	X Walk 1 Width (in)	N/A		Clear Space?	N/A

X Walk 1 Slope (%)	0.7	N/A	Clear Space to XWalk (in)	N/A
	X Walk 1 X Slope (%)	1.4	N/A	Storm Grate/Utility Hazard?	N/A
N/A	Ramp inside XWalk1?	N/A		Storm Grate/Utility Type	
N/A	Any Obstructions?	N/A			N/A
	Obstruction Type		Yes	Surface Condition? (G/P)	Good
			N/A	Curb Slope (%)	4.3

**Remove & Replace Entire Ramp.**

**R304.5.3**
