Access Compliance Report

Public Rights-of-Way

(Curb Ramps)

Intersection ID: 12066	Main Street: WEYLAND_AV	Cross Street: MARLOWE_AV	Location: SE
ADA ID: 6D5817463CB9	Ramp Type: PerpDiag	Initial Pass/Fail: Fail	Overall Compliance: No
		Severity Score: 47.5

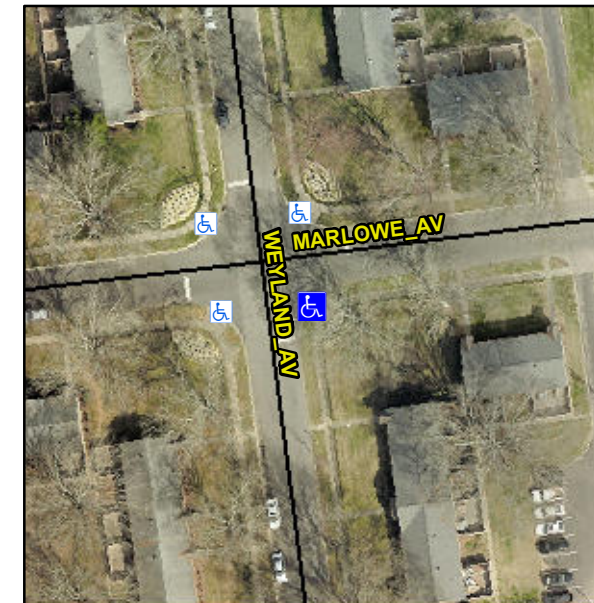
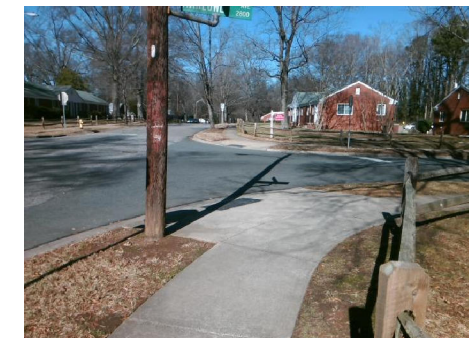
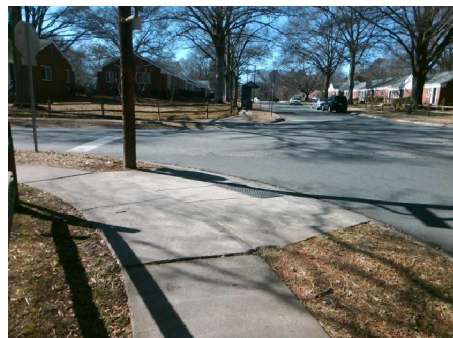
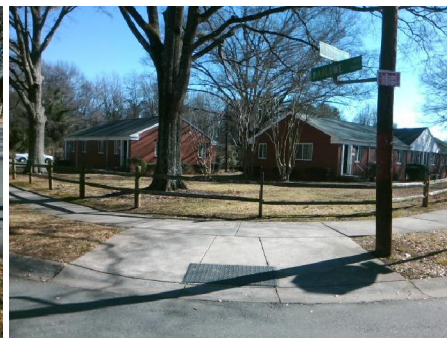
Not Found, R304.5.1, R304.2.2

Compliance	Description	Data	Compliance	Description	Data
N/A	Ramp Length (in)	78.5	No	Ramp Slope (%)	10.3
No	Ramp Width (in)	30.5	Yes	Ramp XSlope (%)	0.2
N/A	Flare Type LT	N/A	N/A	Flare Type RT	N/A
N/A	Flare Slope LT (%)	N/A	N/A	Flare Slope RT (%)	N/A
N/A	Flare Traversable LT?	N/A	N/A	Flare Traversable RT?	N/A
N/A	Landing Length (in)	N/A	N/A	DWS Provided?	N/A
N/A	Landing Width (in)	N/A	N/A	DWS Contrast?	N/A
N/A	Landing Slope (%)	N/A	N/A	DWS Length (in)	N/A
N/A	Landing X Slope (%)	N/A	N/A	DWS Full Width?	N/A
N/A	Landing Curb? (Y/N)	N/A	N/A	DWS Offset (in)	N/A
N/A	Shared Landing?	N/A			
N/A	Gutter Ponding?	N/A	N/A	Gutter Slope (%)	N/A
N/A	Gutter Lip Ht (in)	N/A	N/A	Gutter X Slope (%)	N/A
N/A	Painted X Walk1?	No	N/A	Painted X Walk2?	No
	X Walk 1 Direction	To N		X Walk 2 Direction	To W
N/A	X Walk 1 Width (in)	N/A	N/A	X Walk 2 Width (in)	N/A
	X Walk 1 Slope (%)	2.8		X Walk 2 Slope (%)	4.3
	X Walk 1 X Slope (%)	2.5		X Walk 2 X Slope (%)	2.0

N/A	Ramp inside XWalk1?	N/A	N/A	Ramp inside XWalk2?	N/A
	Road Slope (%)	0.3	N/A	Clear Space?	N/A
	Road X Slope (%)	3.3	N/A	Clear Space to XWalk (in)	N/A
N/A	Any Obstructions?	N/A	N/A	Storm Grate/Utility Hazard?	N/A
	Obstruction Type			Storm Grate/Utility Type	
		N/A			N/A
			Yes	Surface Condition? (G/P)	Good

Remove & Replace Curb Ramp With Two New Directional Ramps or Equivalent.

Total Cost: \$ 3200.00
