# Access Compliance Report

## Public Rights-of-Way (Curb Ramps)

Intersection ID: 12089	Main Street: E_12TH_ST	Cross Street: N_DAVIDSON_ST	Location: W
ADA ID: 6D5ED037D793	Ramp Type: Directional1	Initial Pass/Fail: Fail	Overall Compliance: No
		Severity Score: 12.5

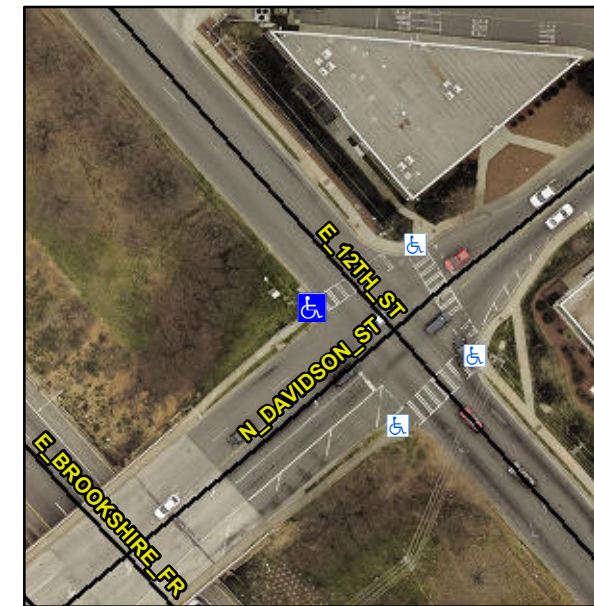
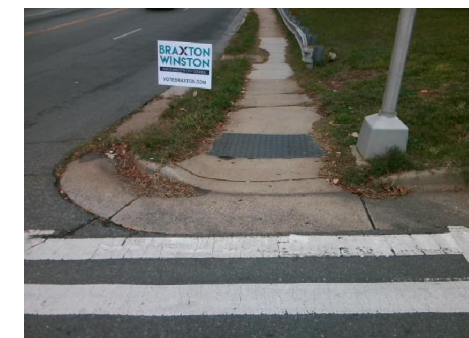
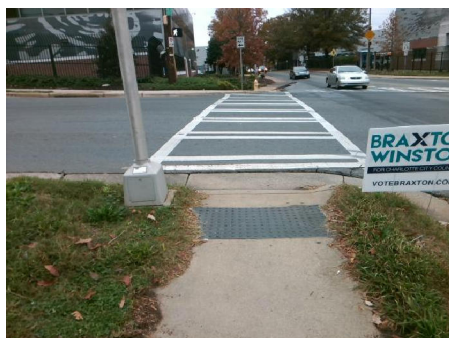
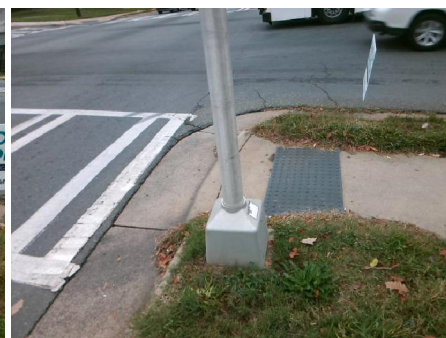
Compliance	Description	Data	Compliance	Description	Data
N/A	Ramp Length (in)	71.0	N/A	Grade Break?	N/A
Yes	Ramp Width (in)	60.0	N/A	Grade Break Slope (%)	0.0
Yes	Ramp Slope (%)	5.6	N/A	Grade Break XSlope (%)	0.0
No	Ramp XSlope (%)	6.7			
N/A	Flare Type LT	N/A	N/A	Flare Type RT	N/A
N/A	Flare Slope LT (%)	N/A	N/A	Flare Slope RT (%)	0.0
N/A	Flare Traversable LT?	N/A	N/A	Flare Traversable RT?	N/A
N/A	Landing Length (in)	0.0	N/A	DWS Provided?	N/A
N/A	Landing Width (in)	0.0	N/A	DWS Contrast?	N/A
N/A	Landing Slope (%)	0.0	N/A	DWS Length (in)	N/A
N/A	Landing X Slope (%)	0.0	N/A	DWS Full Width?	N/A
N/A	Landing Curb? (Y/N)	N/A	N/A	DWS Offset LT (in)	N/A
N/A	Shared Landing?	N/A	N/A	DWS Offset RT (in)	N/A
N/A	Gutter Ponding?	0.0	N/A	Gutter Slope (%)	N/A
N/A	Gutter Lip Ht (in)	0.0	N/A	Gutter X Slope (%)	N/A
N/A	Painted X Walk1?	Yes		Road Slope (%)	3.8
	X Walk 1 Direction	To NE		Road X Slope (%)	5.5
	X Walk 1 Width (in)	104.0		Clear Space?	N/A

X Walk 1 Slope (%)	3.8	N/A	Clear Space to XWalk (in)	N/A
	X Walk 1 X Slope (%)	5.5	N/A	Storm Grate/Utility Hazard?	N/A
N/A	Ramp inside XWalk1?	Yes		Storm Grate/Utility Type	
N/A	Any Obstructions?	N/A			N/A
	Obstruction Type		Yes	Surface Condition? (G/P)	Good
			N/A	Curb Slope (%)	10.9

**Remove & Replace Entire Ramp.**

**R304.5.3**
