Access Compliance Report Public Rights-of-Way (Curb Ramps)

Intersection ID: 12267 Main Street: CENTRAL_AV Cross Street: LOUISE_AV Location: S

ADA ID: 6D641DA29C12 Ramp Type: Perp Initial Pass/Fail: Fail Overall Compliance: No Severity Score: 8.75

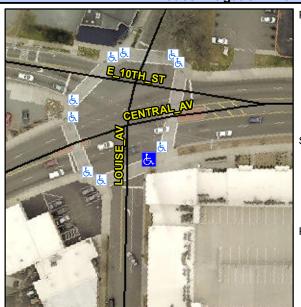
Comp	liance Description	Data	Comp	liance Description	Data
N/A	Ramp Length (in)	102.5	Yes	Ramp Slope (%)	6.8
No	Ramp Width (in)	45.0	Yes	Ramp XSlope (%)	1.7
N/A	Flare Type LT	N/A	N/A	Flare Type RT	N/A
N/A	Flare Slope LT (%)	N/A	N/A	Flare Slope RT (%)	N/A
N/A	Flare Traversable LT?	N/A	N/A	Flare Traversable RT	? N/A
N/A	Landing Length (in)	N/A	N/A	DWS Provided?	N/A
N/A	Landing Width (in)	N/A	N/A	DWS Contrast?	N/A
N/A	Landing Slope (%)	N/A	N/A	DWS Length (in)	N/A
N/A	Landing X Slope (%)	N/A	N/A	DWS Full Width?	N/A
N/A	Landing Curb? (Y/N)	N/A	N/A	DWS Offset (in)	N/A
N/A	Shared Landing?	N/A			
N/A	Gutter Ponding?	N/A	N/A	Gutter Slope (%)	N/A
N/A	Gutter Lip Ht (in)	N/A	N/A	Gutter X Slope (%)	N/A
N/A	Painted X Walk1?	Yes	N/A	Painted X Walk2?	N/A
	X Walk 1 Direction	To W		X Walk 2 Direction	N/A
N/A	X Walk 1 Width (in)	144.0	N/A	X Walk 2 Width (in)	N/A
	X Walk 1 Slope (%)	2.8		X Walk 2 Slope (%)	N/A
	X Walk 1 X Slope (%)	2.2		X Walk 2 X Slope (%)	N/A

N/A	Ramp inside XWalk1?	Yes	N/A	Ramp inside XWalk2	? N/A
	Road Slope (%)	N/A	N/A	Clear Space?	N/A
	Road X Slope (%)	N/A	N/A	Clear Space to XWall	(in) N/A
N/A	Any Obstructions?	N/A	N/A	Storm Grate/Utility Ha	azard? N/A
	Obstruction Type			Storm Grate/Utility Ty	pe
		N/A			N/A
			Yes	Surface Condition? (0	G/P) Good
22

1 033IDIE 30IUIIOII	
Possible Solutions:	Comp
Remove & Replace Entire Ramp.	N/A
·	No
	N/A
	N/A
	N/A
	N/A
Surveyor Notes:	N/A
N/A	N/A
	N/A
	N/A
	N/A
PROW/ADA:	N/A
Not Found, R304.5.1	N/A
·	N/A
	N/A
	N/A

1850.00
