Access Compliance Report

Public Rights-of-Way

(Curb Ramps)

Intersection ID: 30027	Main Street: BRIGHTHAVEN_LN	Cross Street: SMOOTHSTONE_LN	Location: NW
ADA ID: 6D64A763044D	Ramp Type: BlendTrans1	Initial Pass/Fail: Fail	Overall Compliance: No
Severity Score: 25			
Codes/Mitigation Info/Possible Solution		Field Measurements/Component Compliance

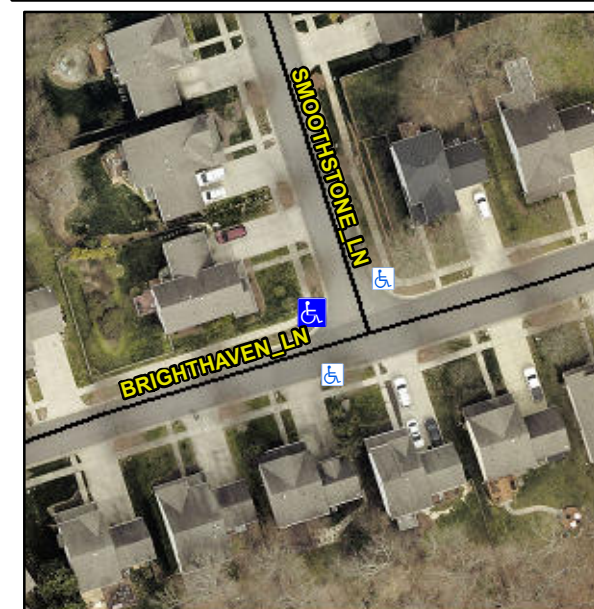
Not Found, R304.5.3

Compliance	Description	Data	Compliance	Description	Data
N/A	Ramp Length (in)	77.5	Yes	BlendTrans Slope (%)	4.2
Yes	Ramp Width (in)	48.0	No	BlendTrans XSlope (%)	8.6
N/A	Flare Type LT	N/A	N/A	Flare Type RT	N/A
N/A	Flare Slope LT (%)	N/A	N/A	Flare Slope RT (%)	N/A
N/A	Flare Traversable LT?	N/A	N/A	Flare Traversable RT?	N/A
N/A	Landing Length (in)	N/A	N/A	DWS Provided?	N/A
N/A	Landing Width (in)	N/A	N/A	DWS Contrast?	N/A
N/A	Landing Slope (%)	N/A	N/A	DWS Length (in)	N/A
N/A	Landing X Slope (%)	N/A	N/A	DWS Full Width?	N/A
N/A	Landing Curb? (Y/N)	N/A	N/A	DWS Offset (in)	N/A
N/A	Shared Landing?	N/A			
N/A	Gutter Ponding?	N/A	N/A	Gutter Slope (%)	N/A
N/A	Gutter Lip Ht (in)	N/A	N/A	Gutter X Slope (%)	N/A
N/A	Painted X Walk1?	No	N/A	Painted X Walk2?	No
	X Walk 1 Direction	To SE		X Walk 2 Direction	To NE
	X Walk 1 Width (in)	N/A		X Walk 2 Width (in)	N/A
	X Walk 1 Slope (%)	1.1		X Walk 2 Slope (%)	11.3
	X Walk 1 X Slope (%)	10.7		X Walk 2 X Slope (%)	0.9

N/A	Ramp inside XWalk1?	N/A	N/A	Ramp inside XWalk2?	N/A
	Road Slope (%)	7.7		Clear Space?	N/A
	Road X Slope (%)	8.5	N/A	Clear Space to XWalk (in)	N/A
N/A	Any Obstructions?	N/A	N/A	Storm Grate/Utility Hazard?	N/A
	Obstruction Type			Storm Grate/Utility Type	
		N/A			N/A
			Yes	Surface Condition? (G/P)	Good
			No	Curb Slope (%)	22.3

Remove & Replace Curb Ramp With Two New Directional Ramps or Equivalent.
