Access Compliance Report Public Rights-of-Way (Curb Ramps)

Intersection ID: 10037884 Main Street: SHARON VIEW RD Cross Street: N/A Location: SW Initial Pass/Fail: Fail **Overall Compliance: No Severity Score:** ADA ID: 6D64A99B883F Ramp Type: PerpDiag 8.75

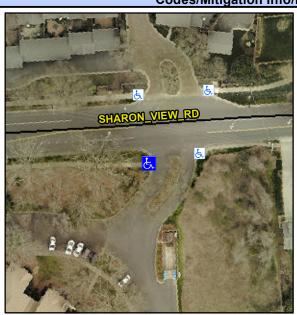
ENTRANCE Street 1 Name Stop Condition-Street 2 None **SHARON VIEW RD** Street 2 Name Stop Condition-Street 1 None Possible Solutions: Remove & Replace Curb Ramp With Two New Directional Ramps or Equivalent. Surveyor Notes: N/A PROW/ADA: R304.5.1
