# Access Compliance Report

## Public Rights-of-Way

### (Curb Ramps)

Intersection ID: 13891	Main Street: CLEMENT_AV	Cross Street: E_7TH_ST	Location: W
ADA ID: 6D6C10BFDBDE	Ramp Type: Directional1	Initial Pass/Fail: Fail	Overall Compliance: No
Severity Score: 1.25			
Codes/Mitigation Info/Possible Solution		Field Measurements/Component Compliance

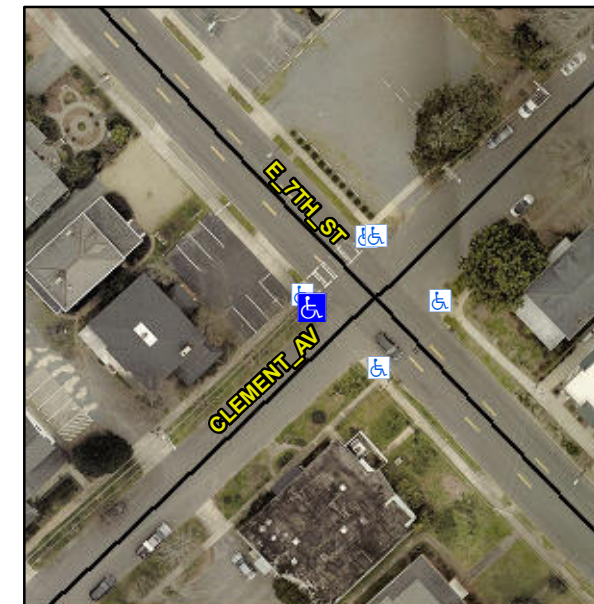
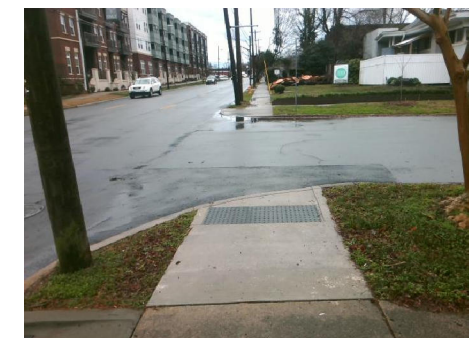
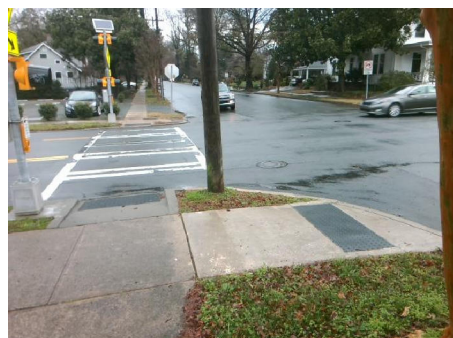
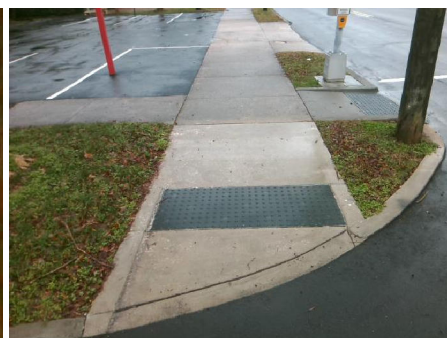
Compliance	Description	Data	Compliance	Description	Data
N/A	Ramp Length (in)	86.0	N/A	Grade Break?	N/A
Yes	Ramp Width (in)	72.0	N/A	Grade Break Slope (%)	0.0
Yes	Ramp Slope (%)	0.5	N/A	Grade Break XSlope (%)	0.0
No	Ramp XSlope (%)	3.1			
N/A	Flare Type LT	N/A	N/A	Flare Type RT	N/A
N/A	Flare Slope LT (%)	N/A	N/A	Flare Slope RT (%)	0.0
N/A	Flare Traversable LT?	N/A	N/A	Flare Traversable RT?	N/A
N/A	Landing Length (in)	0.0	N/A	DWS Provided?	N/A
N/A	Landing Width (in)	0.0	N/A	DWS Contrast?	N/A
N/A	Landing Slope (%)	0.0	N/A	DWS Length (in)	N/A
N/A	Landing X Slope (%)	0.0	N/A	DWS Full Width?	N/A
N/A	Landing Curb? (Y/N)	N/A	N/A	DWS Offset LT (in)	N/A
N/A	Shared Landing?	N/A	N/A	DWS Offset RT (in)	N/A
N/A	Gutter Ponding?	0.0	N/A	Gutter Slope (%)	N/A
N/A	Gutter Lip Ht (in)	0.0	N/A	Gutter X Slope (%)	N/A
N/A	Painted X Walk1?	No		Road Slope (%)	3.1
	X Walk 1 Direction	To SE		Road X Slope (%)	0.4
	X Walk 1 Width (in)	N/A		Clear Space?	N/A

X Walk 1 Slope (%)	3.1	N/A	Clear Space to XWalk (in)	N/A
	X Walk 1 X Slope (%)	0.4	N/A	Storm Grate/Utility Hazard?	N/A
N/A	Ramp inside XWalk1?	N/A		Storm Grate/Utility Type	
N/A	Any Obstructions?	N/A			N/A
	Obstruction Type		Yes	Surface Condition? (G/P)	Good
			N/A	Curb Slope (%)	0.2

**Remove & Replace Entire Ramp.**

**R304.5.3**

\$ 1600.00
