Access Compliance Report

Public Rights-of-Way (Curb Ramps)

Intersection ID: 14859	Main Street: BRIAR_CREEK_RD	Cross Street: COLONNADE_DR	Location: SW
ADA ID: 6D71D0AEE6EF	Ramp Type: Perp	Initial Pass/Fail: Fail	Overall Compliance: No
Severity Score: 12.5			
Codes/Mitigation Info/Possible Solution		Field Measurements/Component Compliance

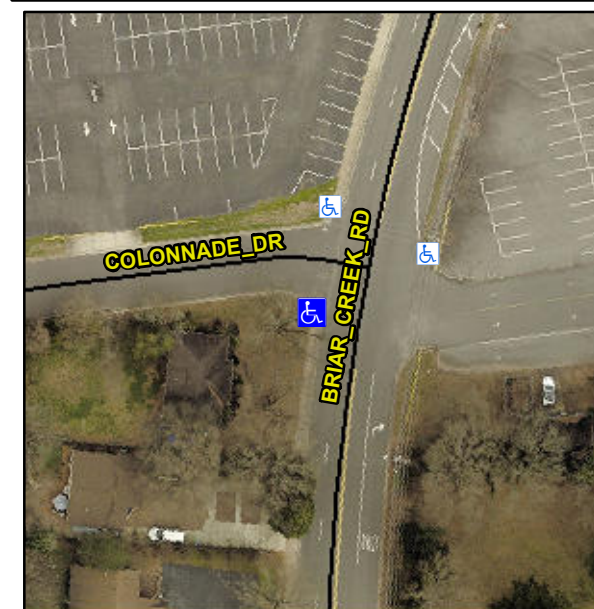
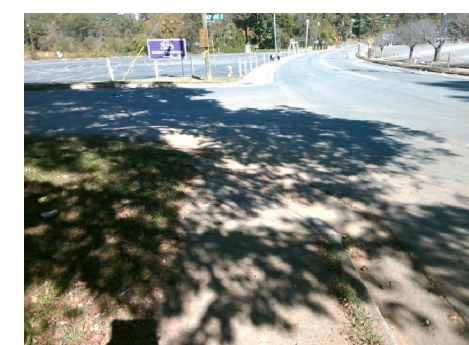
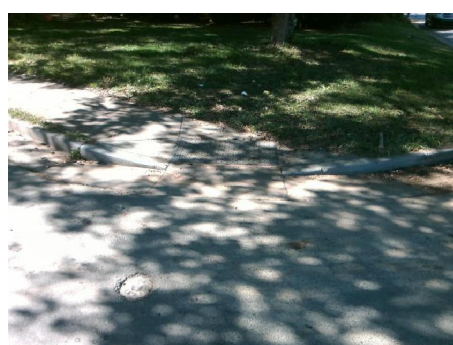
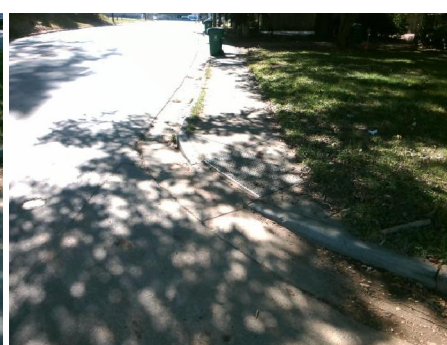
Not Found, R304.2.2

Compliance	Description	Data	Compliance	Description	Data
N/A	Ramp Length (in)	55.0	No	Ramp Slope (%)	11.0
Yes	Ramp Width (in)	49.0	Yes	Ramp XSlope (%)	1.3
N/A	Flare Type LT	N/A	N/A	Flare Type RT	N/A
N/A	Flare Slope LT (%)	N/A	N/A	Flare Slope RT (%)	N/A
N/A	Flare Traversable LT?	N/A	N/A	Flare Traversable RT?	N/A
N/A	Landing Length (in)	N/A	N/A	DWS Provided?	N/A
N/A	Landing Width (in)	N/A	N/A	DWS Contrast?	N/A
N/A	Landing Slope (%)	N/A	N/A	DWS Length (in)	N/A
N/A	Landing X Slope (%)	N/A	N/A	DWS Full Width?	N/A
N/A	Landing Curb? (Y/N)	N/A	N/A	DWS Offset (in)	N/A
N/A	Shared Landing?	N/A			
N/A	Gutter Ponding?	N/A	N/A	Gutter Slope (%)	N/A
N/A	Gutter Lip Ht (in)	0.5	N/A	Gutter X Slope (%)	N/A
N/A	Painted X Walk1?	No	N/A	Painted X Walk2?	N/A
	X Walk 1 Direction	To NE		X Walk 2 Direction	N/A
N/A	X Walk 1 Width (in)	N/A	N/A	X Walk 2 Width (in)	N/A
	X Walk 1 Slope (%)	0.8		X Walk 2 Slope (%)	N/A
	X Walk 1 X Slope (%)	1.9		X Walk 2 X Slope (%)	N/A

N/A	Ramp inside XWalk1?	N/A	N/A	Ramp inside XWalk2?	N/A
	Road Slope (%)	N/A	N/A	Clear Space?	N/A
	Road X Slope (%)	N/A	N/A	Clear Space to XWalk (in)	N/A
N/A	Any Obstructions?	N/A	N/A	Storm Grate/Utility Hazard?	N/A
	Obstruction Type			Storm Grate/Utility Type	
		N/A			N/A
			Yes	Surface Condition? (G/P)	Good

Remove & Replace Entire Ramp.
