Access Compliance Report

Public Rights-of-Way

(Curb Ramps)

Intersection ID: 17673	Main Street: MONROE_RD	Cross Street: OLD_POST_RD	Location: NE
ADA ID: 6D725836230D	Ramp Type: Directional1	Initial Pass/Fail: Fail	Overall Compliance: No
Codes/Mitigation Info/Possible Solution		Field Measurements/Component Compliance	
Severity Score: 1.25

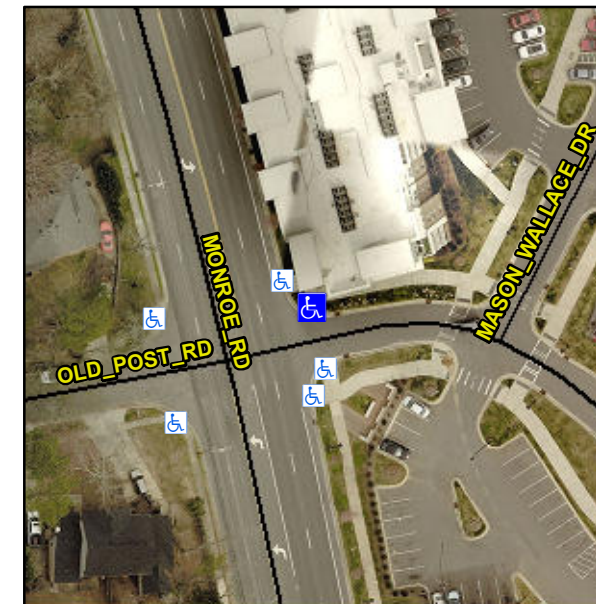
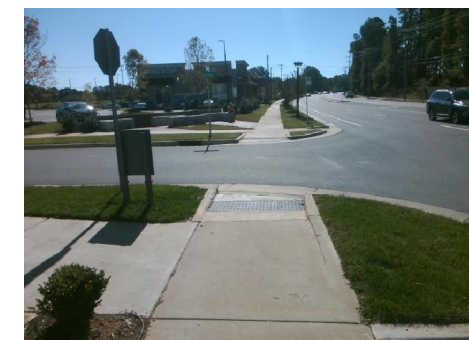
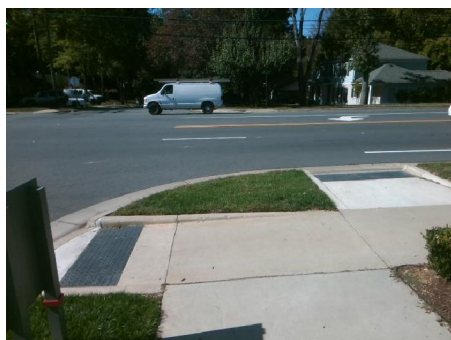
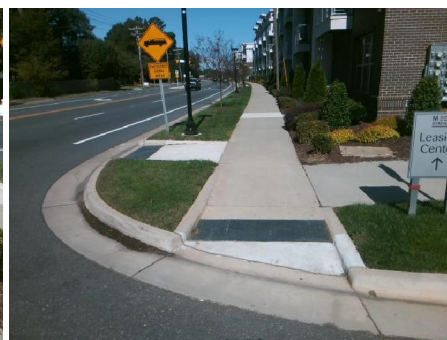
Compliance	Description	Data	Compliance	Description	Data
N/A	Ramp Length (in)	48.0	N/A	Grade Break?	N/A
Yes	Ramp Width (in)	64.0	N/A	Grade Break Slope (%)	0.0
Yes	Ramp Slope (%)	2.9	N/A	Grade Break XSlope (%)	0.0
No	Ramp XSlope (%)	2.7			
N/A	Flare Type LT	N/A	N/A	Flare Type RT	N/A
N/A	Flare Slope LT (%)	N/A	N/A	Flare Slope RT (%)	0.0
N/A	Flare Traversable LT?	N/A	N/A	Flare Traversable RT?	N/A
N/A	Landing Length (in)	0.0	N/A	DWS Provided?	N/A
N/A	Landing Width (in)	0.0	N/A	DWS Contrast?	N/A
N/A	Landing Slope (%)	0.0	N/A	DWS Length (in)	N/A
N/A	Landing X Slope (%)	0.0	N/A	DWS Full Width?	N/A
N/A	Landing Curb? (Y/N)	N/A	N/A	DWS Offset LT (in)	N/A
N/A	Shared Landing?	N/A	N/A	DWS Offset RT (in)	N/A
N/A	Gutter Ponding?	0.0	N/A	Gutter Slope (%)	N/A
N/A	Gutter Lip Ht (in)	0.0	N/A	Gutter X Slope (%)	N/A
N/A	Painted X Walk1?	No		Road Slope (%)	0.8
	X Walk 1 Direction	To SE		Road X Slope (%)	0.7
	X Walk 1 Width (in)	N/A		Clear Space?	N/A

X Walk 1 Slope (%)	0.8	N/A	Clear Space to XWalk (in)	N/A
	X Walk 1 X Slope (%)	0.7	N/A	Storm Grate/Utility Hazard?	N/A
N/A	Ramp inside XWalk1?	N/A		Storm Grate/Utility Type	
N/A	Any Obstructions?	N/A			N/A
	Obstruction Type		Yes	Surface Condition? (G/P)	Good
			N/A	Curb Slope (%)	3.2

Possible Solutions:

Remove & Replace Entire Ramp.
