# Access Compliance Report

## Public Rights-of-Way

### (Curb Ramps)

| Intersection ID: 53181 | Main Street: GOODMAN PARK CT | Cross Street: BASIE PARK CT | Location: SW |

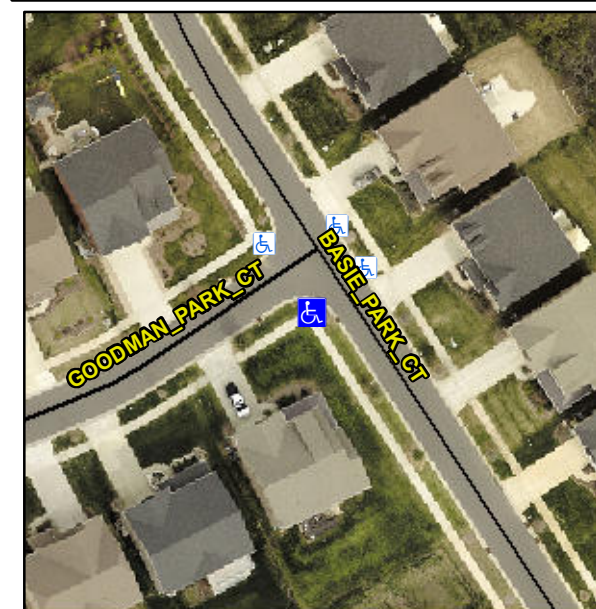
| ADA ID: 6D7854A43BE4 | Ramp Type: PerpDiag | Initial Pass/Fail: Fail | Overall Compliance: No |
| Severity Score: 21.25 | | | |

| Compliance | Description | Data | Compliance | Description | Data |
|---|---|---|---|---|---|
| N/A | Ramp Length (in) | 97.0 | Yes | Ramp Slope (%) | 6.9 |
| No | Ramp Width (in) | 41.0 | No | Ramp XSlope (%) | 6.0 |

**Remove & Replace Curb Ramp With Two New Directional Ramps or Equivalent.**

**R304.5.1, R304.5.3**

Total Cost: \$ 3200.00
