Access Compliance Report

Public Rights-of-Way

(Curb Ramps)

Intersection ID: 3556	Main Street: PROSPERITY_CHURCH_RD	Cross Street: WHITE_CASCADE_DR	Location:	N
ADA ID: 6D7BDEA8C520	Ramp Type: PerpDiag	Initial Pass/Fail: Fail	Overall Compliance: No	Severity Score: 26.25
Codes/Mitigation Info/Possible Solution		Field Measurements/Component Compliance

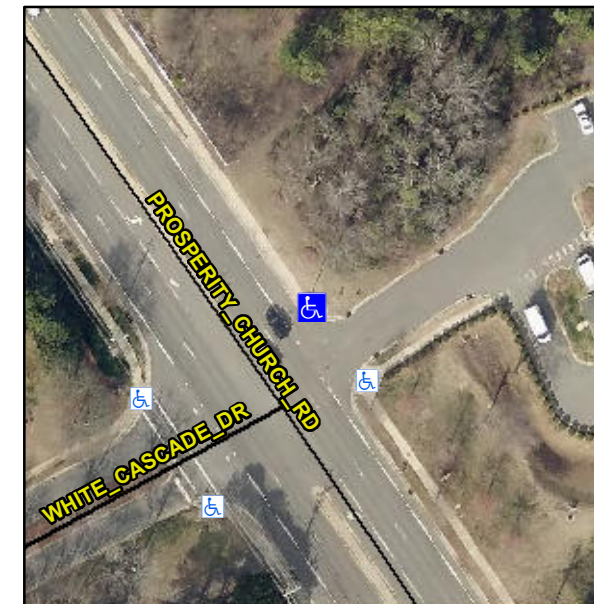
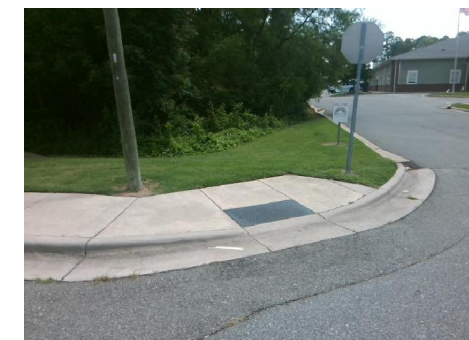
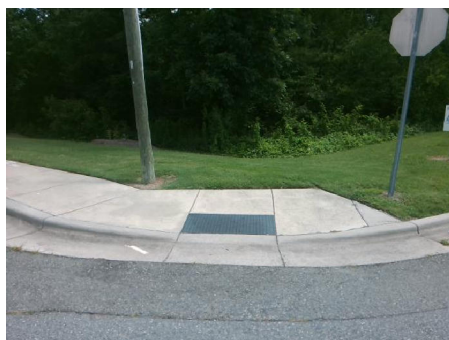
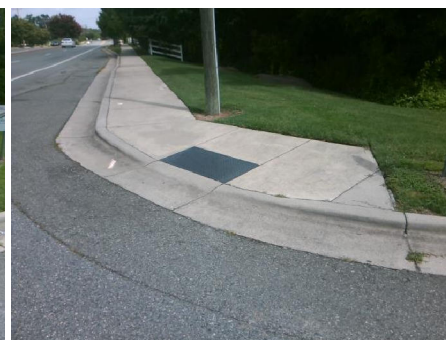
R304.2.2, R304.5.3

Compliance	Description	Data	Compliance	Description	Data
N/A	Ramp Length (in)	66.5	No	Ramp Slope (%)	12.1
Yes	Ramp Width (in)	48.0	No	Ramp XSlope (%)	2.8
N/A	Flare Type LT	N/A	N/A	Flare Type RT	N/A
N/A	Flare Slope LT (%)	N/A	N/A	Flare Slope RT (%)	N/A
N/A	Flare Traversable LT?	N/A	N/A	Flare Traversable RT?	N/A
N/A	Landing Length (in)	N/A	N/A	DWS Provided?	N/A
N/A	Landing Width (in)	N/A	N/A	DWS Contrast?	N/A
N/A	Landing Slope (%)	N/A	N/A	DWS Length (in)	N/A
N/A	Landing X Slope (%)	N/A	N/A	DWS Full Width?	N/A
N/A	Landing Curb? (Y/N)	N/A	N/A	DWS Offset (in)	N/A
N/A	Shared Landing?	N/A			
N/A	Gutter Ponding?	N/A	N/A	Gutter Slope (%)	N/A
N/A	Gutter Lip Ht (in)	N/A	N/A	Gutter X Slope (%)	N/A
N/A	Painted X Walk1?	No	N/A	Painted X Walk2?	No
	X Walk 1 Direction	To SW		X Walk 2 Direction	To SE
N/A	X Walk 1 Width (in)	N/A	N/A	X Walk 2 Width (in)	N/A
	X Walk 1 Slope (%)	1.9		X Walk 2 Slope (%)	1.0
	X Walk 1 X Slope (%)	0.7		X Walk 2 X Slope (%)	4.4

N/A	Ramp inside XWalk1?	N/A	N/A	Ramp inside XWalk2?	N/A
	Road Slope (%)	3.1	N/A	Clear Space?	N/A
	Road X Slope (%)	1.8	N/A	Clear Space to XWalk (in)	N/A
N/A	Any Obstructions?	N/A	N/A	Storm Grate/Utility Hazard?	N/A
	Obstruction Type			Storm Grate/Utility Type	
		N/A			N/A
			Yes	Surface Condition? (G/P)	Good

Remove & Replace Curb Ramp With Two New Directional Ramps or Equivalent.

Total Cost: \$ 3200.00
