# Access Compliance Report

## Public Rights-of-Way

### (Curb Ramps)

Intersection ID: 28495	Main Street: TYVOLA_CENTRE_DR	Cross Street: CAMERON_WALK_CT	Location: SE
ADA ID: 6D8689454064	Ramp Type: PerpDiag	Initial Pass/Fail: Pass	Overall Compliance: No
Severity Score: 10.25			
Codes/Mitigation Info/Possible Solution		Field Measurements/Component Compliance

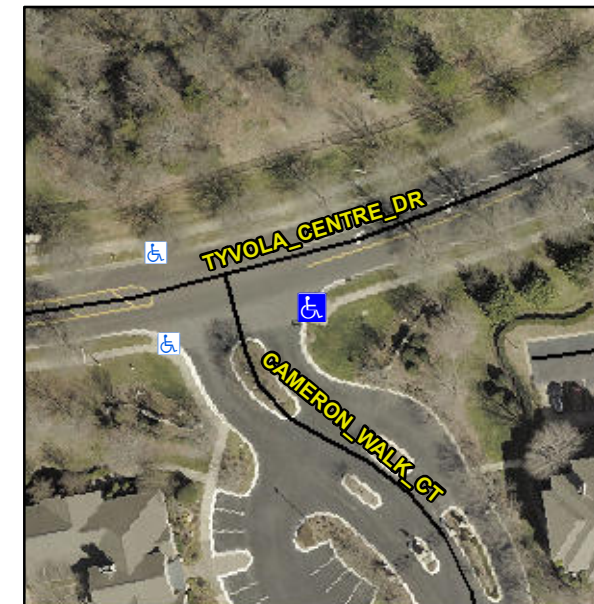
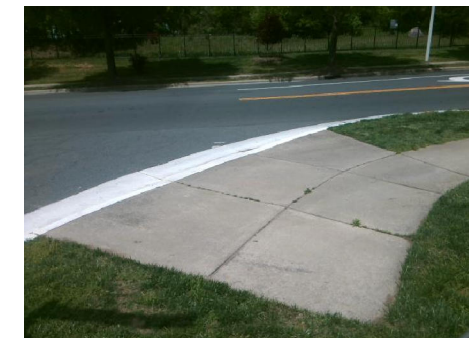
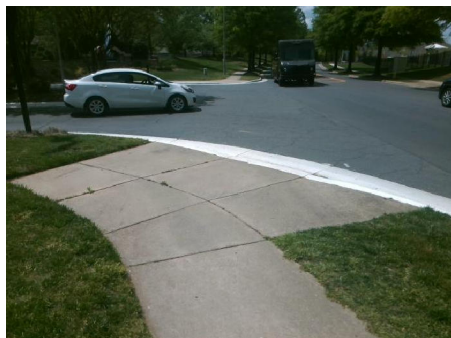
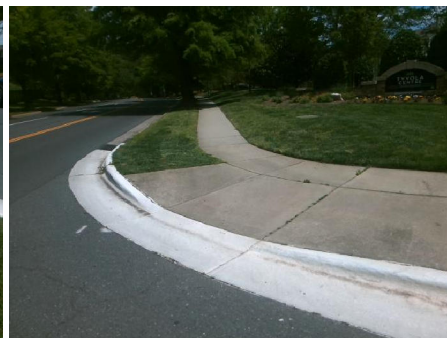
**Not Found, R304.5.3, R304.2.2-Perp, R304.3.2-Para, R305**

Compliance	Description	Data	Compliance	Description	Data
N/A	Ramp Length (in)	70.0	Yes	Ramp Slope (%)	7.6
Yes	Ramp Width (in)	60.0	No	Ramp XSlope (%)	3.7
N/A	Flare Type LT	Sloped	N/A	Flare Type RT	N/A
N/A	Flare Slope LT (%)	11.3	N/A	Flare Slope RT (%)	4.8
N/A	Flare Traversable LT?	No	N/A	Flare Traversable RT?	No
Yes	Landing Length (in)	48.0	No	DWS Provided?	No
Yes	Landing Width (in)	60.0	N/A	DWS Contrast?	No
No	Landing Slope (%)	2.3	N/A	DWS Length (in)	N/A
No	Landing X Slope (%)	3.4	N/A	DWS Full Width?	No
N/A	Landing Curb? (Y/N)	No	N/A	DWS Offset (in)	N/A
N/A	Shared Landing?	No			
Yes	Gutter Ponding?	No	Yes	Gutter Slope (%)	3.2
Yes	Gutter Lip Ht (in)	0.0	No	Gutter X Slope (%)	4.2
N/A	Painted X Walk1?	No	N/A	Painted X Walk2?	No
	X Walk 1 Direction	To N		X Walk 2 Direction	To W
N/A	X Walk 1 Width (in)	N/A	N/A	X Walk 2 Width (in)	N/A
	X Walk 1 Slope (%)	0.5		X Walk 2 Slope (%)	3.1
	X Walk 1 X Slope (%)	2.9		X Walk 2 X Slope (%)	2.0

N/A	Ramp inside XWalk1?	N/A	N/A	Ramp inside XWalk2?	N/A
	Road Slope (%)	3.5	N/A	Clear Space?	Yes
	Road X Slope (%)	0.8	N/A	Clear Space to XWalk (in)	N/A
Yes	Any Obstructions?	No	Yes	Storm Grate/Utility Hazard?	No
	Obstruction Type			Storm Grate/Utility Type	
		N/A			N/A
		Yes		Surface Condition? (G/P)	Good

**Remove & Replace Curb Ramp With Two New Directional Ramps or Equivalent. Remove & Replace Gutter.**

Total Cost: \$ 3950.00
