Access Compliance Report

Public Rights-of-Way

(Curb Ramps)

Intersection ID: 52610		Main Street: LEGRANGER_RD		Cross Street: HERITAGE_POND_DR		Location: SW													
ADA ID: 6D9725A4BAF9		Ramp Type: Directional1		Initial Pass/Fail: Fail		Overall Compliance: No		Severity Score: 13.75											
Codes/Mitigation Info/Possible Solution				Field Measurements/Component Compliance															
<div>

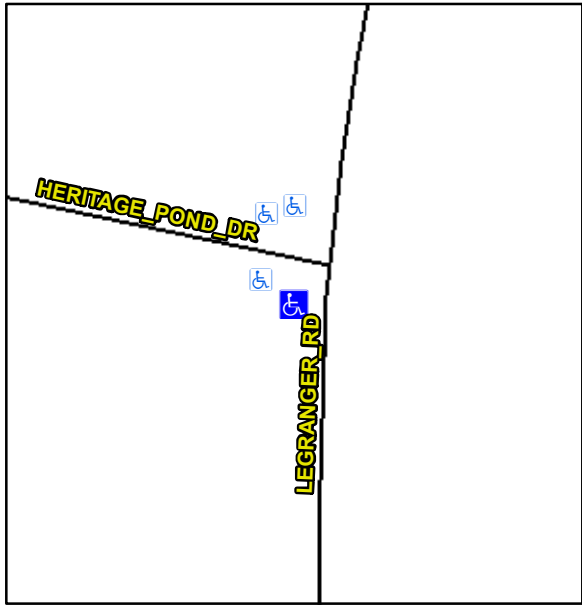
</div> <div>Street 1 NameLEGRANGER RD</div> <div>Stop Condition-Street 1None</div> <div>Street 2 NameN/A</div> <div>Stop Condition-Street 2N/A</div>				Possible Solutions:		Compliance		Description		Data		Compliance		Description		Data			
				Remove & Replace Entire Ramp.		N/A		Ramp Length (in)		55.0		N/A		Grade Break?		N/A		N/A	
				Surveyor Notes: N/A		Yes		Ramp Width (in)		63.5		N/A		Grade Break Slope (%)		0.0		N/A	
						No		Ramp Slope (%)		10.2		N/A		Grade Break XSlope (%)		0.0		N/A	
						Yes		Ramp XSlope (%)		4.1									
						N/A		Flare Type LT		N/A		N/A		Flare Type RT		N/A		N/A

N/A		Flare Slope LT (%)		N/A		N/A		Flare Slope RT (%)		0.0		N/A	
						N/A		Flare Traversable LT?		N/A		N/A		Flare Traversable RT?		N/A		N/A	
						N/A		Landing Length (in)		0.0		N/A		DWS Provided?		N/A		N/A	
						N/A		Landing Width (in)		0.0		N/A		DWS Contrast?		N/A		N/A	
						N/A		Landing Slope (%)		0.0		N/A		DWS Length (in)		N/A		N/A	
						N/A		Landing X Slope (%)		0.0		N/A		DWS Full Width?		N/A		N/A	
				PROW/ADA: R304.2.2		N/A		Landing Curb? (Y/N)		N/A		N/A		DWS Offset LT (in)		N/A		N/A	
						N/A		Shared Landing?		N/A		N/A		DWS Offset RT (in)		N/A		N/A	
						N/A		Gutter Ponding?		0.0		N/A		Gutter Slope (%)		N/A		N/A	
						N/A		Gutter Lip Ht (in)		0.0		N/A		Gutter X Slope (%)		N/A		N/A	
						N/A		Painted X Walk1?		No				Road Slope (%)		1.8		N/A	
								X Walk 1 Direction		To E				Road X Slope (%)		5.7		N/A	
								X Walk 1 Width (in)		N/A				Clear Space?		N/A		N/A	
								X Walk 1 Slope (%)		1.8		N/A		Clear Space to XWalk (in)		N/A		N/A

X Walk 1 X Slope (%)		5.7		N/A		Storm Grate/Utility Hazard?		N/A		N/A	
						N/A		Ramp inside XWalk1?		N/A				Storm Grate/Utility Type					
						Any Obstructions?		N/A						N/A		N/A			
						Obstruction Type				Yes		Surface Condition? (G/P)		Good					
										N/A		N/A		Curb Slope (%)		N/A			
				Total Cost:				\$		1600.00
