## **Access Compliance Report Public Rights-of-Way** (Curb Ramps)

Intersection ID: 28728 Main Street: ABSON\_CT Cross Street: STEWARTS\_CROSSING\_DR Location: Е ADA ID: 6D9AA7520334 Ramp Type: Perp Initial Pass/Fail: Fail **Overall Compliance: No Severity Score:** 10

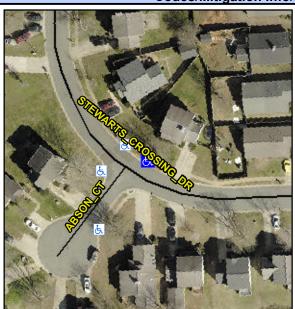
Field Measurements/Component Compliance							
Comp	liance Description	Data	Comp	liance Description	Data		
N/A	Ramp Length (in)	48.5	Yes	Ramp Slope (%)	7.6		
No	Ramp Width (in)	47.5	Yes	Ramp XSlope (%)	3.3		
N/A	Flare Type LT	N/A	N/A	Flare Type RT	N/A		
N/A	Flare Slope LT (%)	N/A	N/A	Flare Slope RT (%)	N/A		
N/A	Flare Traversable LT?	N/A	N/A	Flare Traversable RT?	N/A		
N/A	Landing Length (in)	N/A	N/A	DWS Provided?	N/A		
N/A	Landing Width (in)	N/A	N/A	DWS Contrast?	N/A		
N/A	Landing Slope (%)	N/A	N/A	DWS Length (in)	N/A		
N/A	Landing X Slope (%)	N/A	N/A	DWS Full Width?	N/A		
N/A	Landing Curb? (Y/N)	N/A	N/A	DWS Offset (in)	N/A		
N/A	Shared Landing?	N/A					
N/A	Gutter Ponding?	N/A	N/A	Gutter Slope (%)	N/A		
N/A	Gutter Lip Ht (in)	N/A	N/A	Gutter X Slope (%)	N/A		
N/A	Painted X Walk1?	No	N/A	Painted X Walk2?	N/A		
	X Walk 1 Direction	To SW		X Walk 2 Direction	N/A		
N/A	X Walk 1 Width (in)	N/A	N/A	X Walk 2 Width (in)	N/A

X Walk 1 Slope (%)	2.5		X Walk 2 Slope (%)	N/A		
	X Walk 1 X Slope (%)	3.8		X Walk 2 X Slope (%)	N/A		
N/A	Ramp inside XWalk1?	N/A	N/A	Ramp inside XWalk2?	N/A		
	Road Slope (%)	N/A	N/A	Clear Space?	N/A		
	Road X Slope (%)	N/A	N/A	Clear Space to XWalk (in)	N/A		
N/A	Any Obstructions?	N/A	N/A	Storm Grate/Utility Hazard?	N/A		
	Obstruction Type			Storm Grate/Utility Type			
		N/A			N/A		
			Yes	Surface Condition? (G/P)	Good		
1

1 0331bic Goldtion	
Possible Solutions:	9
Remove & Replace Entire Ramp.	N
•	1
	N
	N
	1
	1
Surveyor Notes:	1
N/A	1
	1
	1
	1
PROW/ADA:	1
Not Found, R304.5.1	N
	1
