Access Compliance Report

Public Rights-of-Way

(Curb Ramps)

Intersection ID: 19024	Main Street: CAVENDISH_CT	Cross Street: PROVIDENCE_RD	Location: NW
ADA ID: 6DA9E987C23F	Ramp Type: ParaDiag	Initial Pass/Fail: Fail	Overall Compliance: No
Severity Score: 31.25			
Codes/Mitigation Info/Possible Solution		Field Measurements/Component Compliance

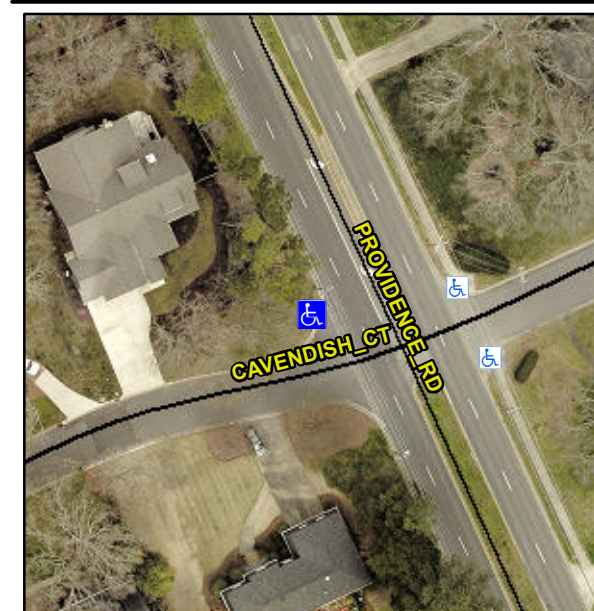
Surveyor Notes:

MEDIAN ACROSS PROVIDENCE RD

PROW/ADA:

R304.5.1, R304.5.3, R304.3.2

Compliance	Description	Data	Compliance	Description	Data
N/A	Ramp Length LT (in)	57.0	N/A	Ramp Length RT (in)	54.0
No	Ramp Width LT (in)	33.5	No	Ramp Width RT (in)	34.0
Yes	Ramp Slope LT (%)	3.9	No	Ramp Slope RT (%)	11.6
No	Ramp XSlope LT (%)	2.7	No	Ramp XSlope RT (%)	3.1
N/A	Landing Length (in)	N/A	N/A	DWS Provided?	N/A
N/A	Landing Width (in)	N/A	N/A	DWS Contrast?	N/A
N/A	Landing Slope (%)	N/A	N/A	DWS Length (in)	N/A
N/A	Landing X Slope (%)	N/A	N/A	DWS Full Width?	N/A
N/A	Landing Curb? (Y/N)	N/A	N/A	DWS Offset (in)	N/A
N/A	Shared Landing?	N/A			
N/A	Gutter Ponding?	N/A	N/A	Gutter Slope (%)	N/A
N/A	Gutter Lip Ht (in)	N/A	N/A	Gutter X Slope (%)	N/A
N/A	Painted X Walk1?	No	N/A	Painted X Walk2?	No
	X Walk 1 Direction	To S		X Walk 2 Direction	To E
N/A	X Walk 1 Width (in)	N/A	N/A	X Walk 2 Width (in)	N/A
	X Walk 1 Slope (%)	4.4		X Walk 2 Slope (%)	11.8
	X Walk 1 X Slope (%)	11.8		X Walk 2 X Slope (%)	1.7
N/A	Ramp inside XWalk1?	N/A	N/A	Ramp inside XWalk2?	N/A

Road Slope (%)	7.3	N/A	Clear Space?	N/A
	Road X Slope (%)	9.3	N/A	Clear Space to XWalk (in)	N/A
N/A	Any Obstructions?	N/A	N/A	Storm Grate/Utility Hazard?	N/A
	Obstruction Type			Storm Grate/Utility Type	
		N/A			N/A
			Yes	Surface Condition? (G/P)	Good
			N/A	Curb Slope (%)	4.8

Possible Solutions:

Remove & Replace Curb Ramp With Two New Directional Ramps or Equivalent.
