# Access Compliance Report

## Public Rights-of-Way

### (Curb Ramps)

Intersection ID: 3090	Main Street: AVALON_FOREST_LN	Cross Street: PANTHERSVILLE_DR	Location: SE
ADA ID: 6DAA17BAE275	Ramp Type: Perp	Initial Pass/Fail: Fail	Overall Compliance: No
Severity Score: 10			
Codes/Mitigation Info/Possible Solution		Field Measurements/Component Compliance

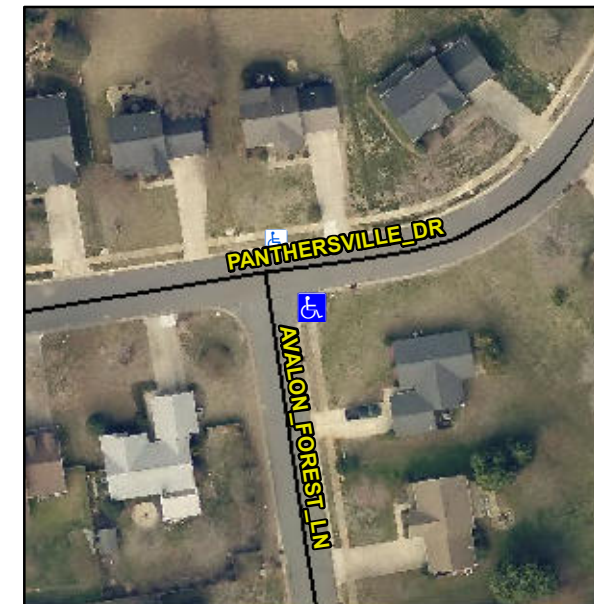
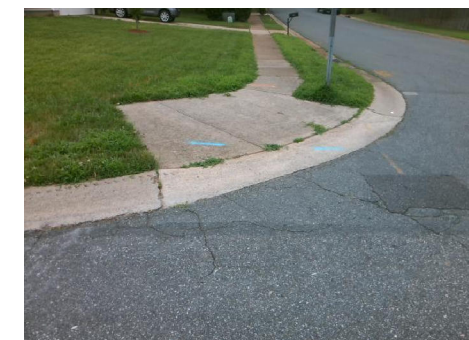
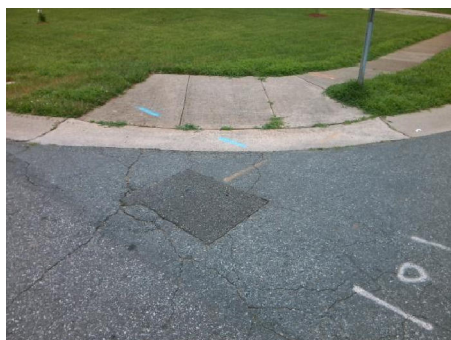
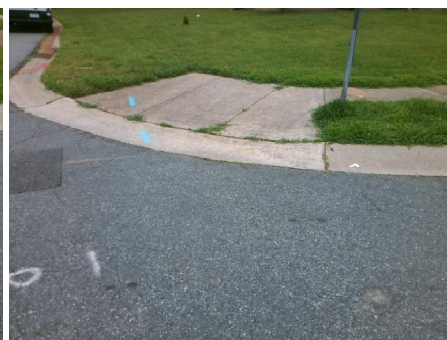
**R304.5.1, R304.5.3**

Compliance	Description	Data	Compliance	Description	Data
N/A	Ramp Length (in)	93.5	Yes	Ramp Slope (%)	7.0
No	Ramp Width (in)	47.0	No	Ramp XSlope (%)	2.1
N/A	Flare Type LT	N/A	N/A	Flare Type RT	N/A
N/A	Flare Slope LT (%)	N/A	N/A	Flare Slope RT (%)	N/A
N/A	Flare Traversable LT?	N/A	N/A	Flare Traversable RT?	N/A
N/A	Landing Length (in)	N/A	N/A	DWS Provided?	N/A
N/A	Landing Width (in)	N/A	N/A	DWS Contrast?	N/A
N/A	Landing Slope (%)	N/A	N/A	DWS Length (in)	N/A
N/A	Landing X Slope (%)	N/A	N/A	DWS Full Width?	N/A
N/A	Landing Curb? (Y/N)	N/A	N/A	DWS Offset (in)	N/A
N/A	Shared Landing?	N/A			
N/A	Gutter Ponding?	N/A	N/A	Gutter Slope (%)	N/A
N/A	Gutter Lip Ht (in)	N/A	N/A	Gutter X Slope (%)	N/A
N/A	Painted X Walk1?	No	N/A	Painted X Walk2?	N/A
	X Walk 1 Direction	To N		X Walk 2 Direction	N/A
N/A	X Walk 1 Width (in)	N/A	N/A	X Walk 2 Width (in)	N/A
	X Walk 1 Slope (%)	3.2		X Walk 2 Slope (%)	N/A
	X Walk 1 X Slope (%)	0.3		X Walk 2 X Slope (%)	N/A

N/A	Ramp inside XWalk1?	N/A	N/A	Ramp inside XWalk2?	N/A
	Road Slope (%)	N/A	N/A	Clear Space?	N/A
	Road X Slope (%)	N/A	N/A	Clear Space to XWalk (in)	N/A
N/A	Any Obstructions?	N/A	N/A	Storm Grate/Utility Hazard?	N/A
	Obstruction Type			Storm Grate/Utility Type	
		N/A			N/A
			Yes	Surface Condition? (G/P)	Good

**Remove & Replace Entire Ramp.**

Total Cost: \$ 1850.00
