# Access Compliance Report

## Public Rights-of-Way

### (Curb Ramps)

Intersection ID: 47230	Main Street: MOREHEAD_MEDICAL_DR	Cross Street: E_MOREHEAD_ST	Location: W
ADA ID: 6DB018DBFB02	Ramp Type: PerpDiag	Initial Pass/Fail: Fail	Overall Compliance: No
Severity Score: 13.75			
Codes/Mitigation Info/Possible Solution		Field Measurements/Component Compliance

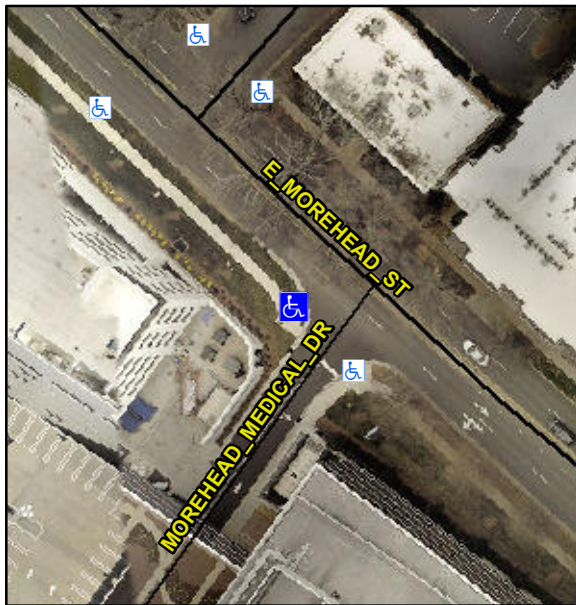
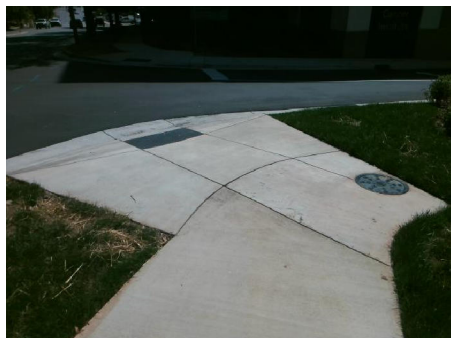
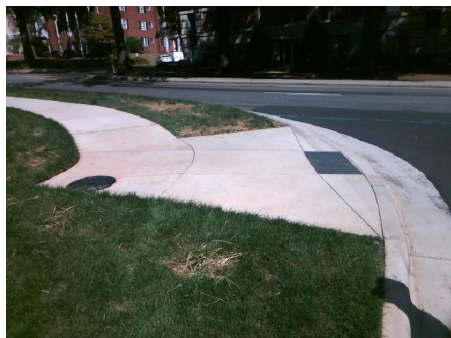
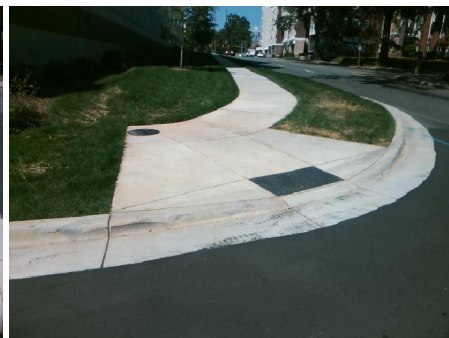
**Not Found, R304.2.2, R304.5.3**

Compliance	Description	Data	Compliance	Description	Data
N/A	Ramp Length (in)	96.0	No	Ramp Slope (%)	9.1
Yes	Ramp Width (in)	49.5	No	Ramp XSlope (%)	2.6
N/A	Flare Type LT	N/A	N/A	Flare Type RT	N/A
N/A	Flare Slope LT (%)	N/A	N/A	Flare Slope RT (%)	N/A
N/A	Flare Traversable LT?	N/A	N/A	Flare Traversable RT?	N/A
N/A	Landing Length (in)	N/A	N/A	DWS Provided?	N/A
N/A	Landing Width (in)	N/A	N/A	DWS Contrast?	N/A
N/A	Landing Slope (%)	N/A	N/A	DWS Length (in)	N/A
N/A	Landing X Slope (%)	N/A	N/A	DWS Full Width?	N/A
N/A	Landing Curb? (Y/N)	N/A	N/A	DWS Offset (in)	N/A
N/A	Shared Landing?	N/A			
N/A	Gutter Ponding?	N/A	N/A	Gutter Slope (%)	N/A
N/A	Gutter Lip Ht (in)	N/A	N/A	Gutter X Slope (%)	N/A
N/A	Painted X Walk1?	No	N/A	Painted X Walk2?	No
	X Walk 1 Direction	To SE		X Walk 2 Direction	To NE
N/A	X Walk 1 Width (in)	N/A	N/A	X Walk 2 Width (in)	N/A
	X Walk 1 Slope (%)	1.0		X Walk 2 Slope (%)	3.1
	X Walk 1 X Slope (%)	4.5		X Walk 2 X Slope (%)	1.8

N/A	Ramp inside XWalk1?	N/A	N/A	Ramp inside XWalk2?	N/A
	Road Slope (%)	3.3	N/A	Clear Space?	N/A
	Road X Slope (%)	0.7	N/A	Clear Space to XWalk (in)	N/A
N/A	Any Obstructions?	N/A	N/A	Storm Grate/Utility Hazard?	N/A
	Obstruction Type			Storm Grate/Utility Type	
		N/A			N/A
			Yes	Surface Condition? (G/P)	Good

**Remove & Replace Curb Ramp With Two New Directional Ramps or Equivalent.**
