Access Compliance Report

Public Rights-of-Way

(Curb Ramps)

Intersection ID: 17341	Main Street: AUTUMN_RAIN_LN	Cross Street: SHADOW_ELM_DR	Location:	NE
ADA ID: 6DB6E790BD68	Ramp Type: PerpDiag	Initial Pass/Fail: Fail	Overall Compliance: No	Severity Score: 25
Codes/Mitigation Info/Possible Solution		Field Measurements/Component Compliance

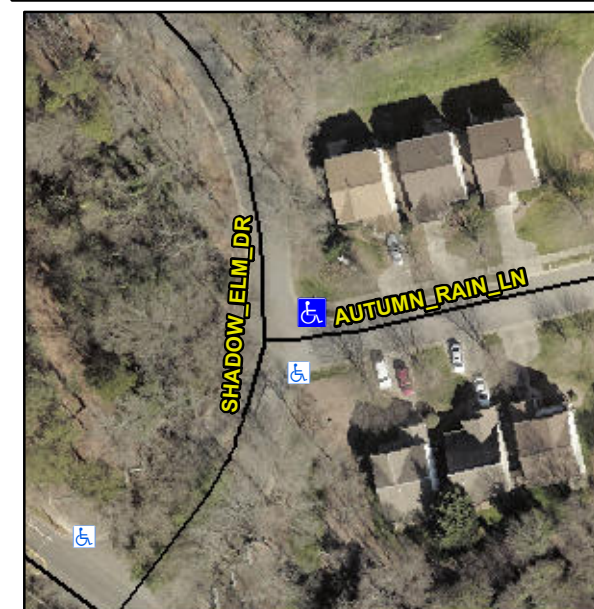
Not Found, R304.5.3

Compliance	Description	Data	Compliance	Description	Data
N/A	Ramp Length (in)	96.0	Yes	Ramp Slope (%)	5.4
Yes	Ramp Width (in)	60.0	No	Ramp XSlope (%)	7.3
N/A	Flare Type LT	N/A	N/A	Flare Type RT	N/A
N/A	Flare Slope LT (%)	N/A	N/A	Flare Slope RT (%)	N/A
N/A	Flare Traversable LT?	N/A	N/A	Flare Traversable RT?	N/A
N/A	Landing Length (in)	N/A	N/A	DWS Provided?	N/A
N/A	Landing Width (in)	N/A	N/A	DWS Contrast?	N/A
N/A	Landing Slope (%)	N/A	N/A	DWS Length (in)	N/A
N/A	Landing X Slope (%)	N/A	N/A	DWS Full Width?	N/A
N/A	Landing Curb? (Y/N)	N/A	N/A	DWS Offset (in)	N/A
N/A	Shared Landing?	N/A			
N/A	Gutter Ponding?	N/A	N/A	Gutter Slope (%)	N/A
N/A	Gutter Lip Ht (in)	N/A	N/A	Gutter X Slope (%)	N/A
N/A	Painted X Walk1?	No	N/A	Painted X Walk2?	No
	X Walk 1 Direction	To W		X Walk 2 Direction	To SW
N/A	X Walk 1 Width (in)	N/A	N/A	X Walk 2 Width (in)	N/A
	X Walk 1 Slope (%)	4.6		X Walk 2 Slope (%)	1.0
	X Walk 1 X Slope (%)	0.7		X Walk 2 X Slope (%)	4.9

N/A	Ramp inside XWalk1?	N/A	N/A	Ramp inside XWalk2?	N/A
	Road Slope (%)	4.4	N/A	Clear Space?	N/A
	Road X Slope (%)	4.2	N/A	Clear Space to XWalk (in)	N/A
N/A	Any Obstructions?	N/A	N/A	Storm Grate/Utility Hazard?	N/A
	Obstruction Type			Storm Grate/Utility Type	
		N/A			N/A
		Yes		Surface Condition? (G/P)	Good

Remove & Replace Curb Ramp With Two New Directional Ramps or Equivalent.
