Access Compliance Report

Public Rights-of-Way

(Curb Ramps)

Intersection ID: 10038340	Main Street: SOUTH_BV	Cross Street: N/A	Location: SW
ADA ID: 6DBB1031030A	Ramp Type: Perp	Initial Pass/Fail: Fail	Overall Compliance: No
		Severity Score: 12.5

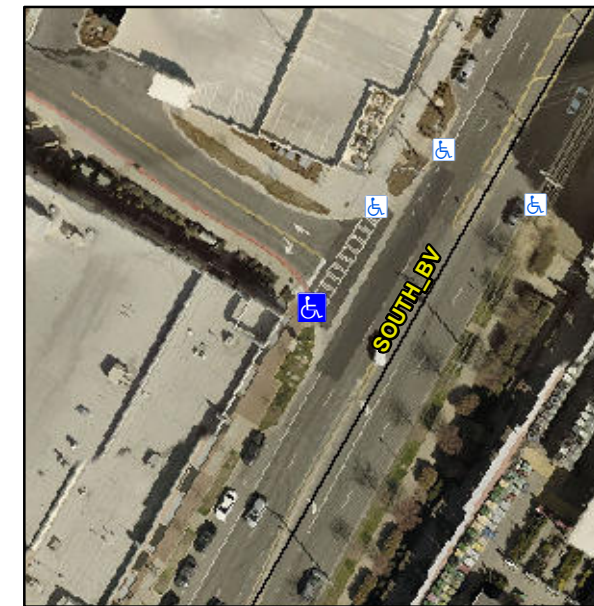
Not Found, R304.2.2

Compliance	Description	Data	Compliance	Description	Data
N/A	Ramp Length (in)	63.0	No	Ramp Slope (%)	11.0
Yes	Ramp Width (in)	48.0	Yes	Ramp XSlope (%)	0.8
N/A	Flare Type LT	N/A	N/A	Flare Type RT	N/A
N/A	Flare Slope LT (%)	N/A	N/A	Flare Slope RT (%)	N/A
N/A	Flare Traversable LT?	N/A	N/A	Flare Traversable RT?	N/A
N/A	Landing Length (in)	N/A	N/A	DWS Provided?	N/A
N/A	Landing Width (in)	N/A	N/A	DWS Contrast?	N/A
N/A	Landing Slope (%)	N/A	N/A	DWS Length (in)	N/A
N/A	Landing X Slope (%)	N/A	N/A	DWS Full Width?	N/A
N/A	Landing Curb? (Y/N)	N/A	N/A	DWS Offset (in)	N/A
N/A	Shared Landing?	N/A			
N/A	Gutter Ponding?	N/A	N/A	Gutter Slope (%)	N/A
N/A	Gutter Lip Ht (in)	N/A	N/A	Gutter X Slope (%)	N/A
N/A	Painted X Walk1?	Yes	N/A	Painted X Walk2?	N/A
	X Walk 1 Direction	To NE		X Walk 2 Direction	N/A
N/A	X Walk 1 Width (in)	113.0	N/A	X Walk 2 Width (in)	N/A
	X Walk 1 Slope (%)	1.8		X Walk 2 Slope (%)	N/A
	X Walk 1 X Slope (%)	1.1		X Walk 2 X Slope (%)	N/A

Remove & Replace Entire Ramp.
