Access Compliance Report

Public Rights-of-Way

(Curb Ramps)

Intersection ID: 29810	Main Street: MCCLURE_MANOR_DR	Cross Street: SYDENHAM_CT	Location: NW
ADA ID: 6DCDA8A1261E	Ramp Type: BlendTrans2	Initial Pass/Fail: Fail	Overall Compliance: No
Severity Score: 25			
Codes/Mitigation Info/Possible Solution		Field Measurements/Component Compliance

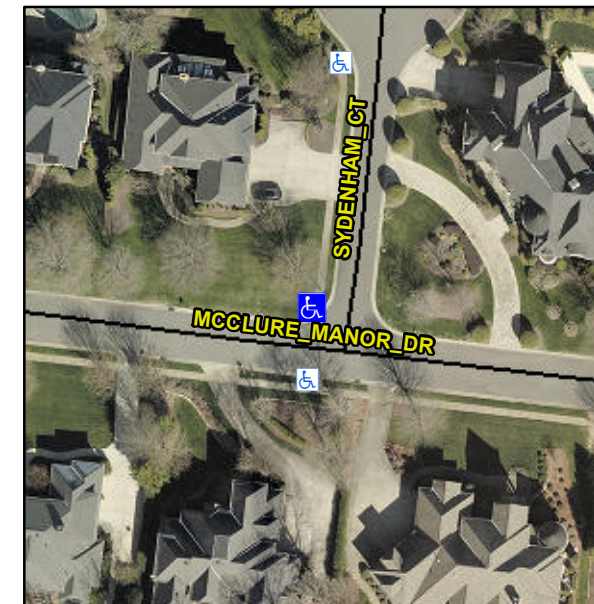
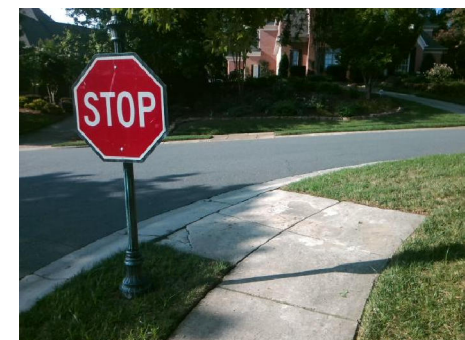
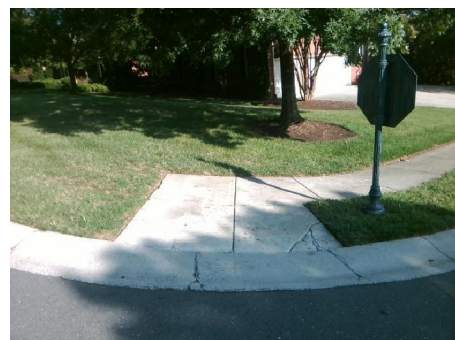
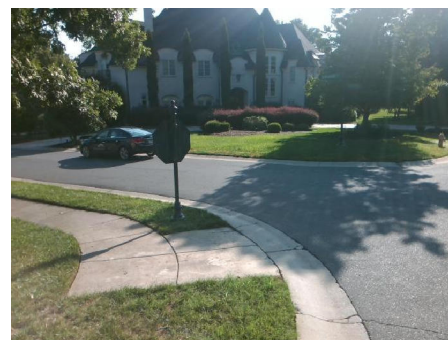
DAMAGED RAMP

Not Found, R304.5.3

Compliance	Description	Data	Compliance	Description	Data
N/A	Ramp Length (in)	98.0	Yes	BlendTrans Slope (%)	3.4
Yes	Ramp Width (in)	85.0	No	BlendTrans XSlope (%)	15.0
N/A	Flare Type LT	N/A	N/A	Flare Type RT	N/A
N/A	Flare Slope LT (%)	N/A	N/A	Flare Slope RT (%)	N/A
N/A	Flare Traversable LT?	N/A	N/A	Flare Traversable RT?	N/A
N/A	Landing Length (in)	N/A	N/A	DWS Provided?	N/A
N/A	Landing Width (in)	N/A	N/A	DWS Contrast?	N/A
N/A	Landing Slope (%)	N/A	N/A	DWS Length (in)	N/A
N/A	Landing X Slope (%)	N/A	N/A	DWS Full Width?	N/A
N/A	Landing Curb? (Y/N)	N/A	N/A	DWS Offset (in)	N/A
N/A	Shared Landing?	N/A			
N/A	Gutter Ponding?	N/A	N/A	Gutter Slope (%)	N/A
N/A	Gutter Lip Ht (in)	N/A	N/A	Gutter X Slope (%)	N/A
N/A	Painted X Walk1?	No	N/A	Painted X Walk2?	No
	X Walk 1 Direction	To S		X Walk 2 Direction	To E
	X Walk 1 Width (in)	N/A		X Walk 2 Width (in)	N/A
	X Walk 1 Slope (%)	7.0		X Walk 2 Slope (%)	3.1
	X Walk 1 X Slope (%)	8.6		X Walk 2 X Slope (%)	8.5

N/A	Ramp inside XWalk1?	N/A	N/A	Ramp inside XWalk2?	N/A
	Road Slope (%)	10.0		Clear Space?	N/A
	Road X Slope (%)	0.9	N/A	Clear Space to XWalk (in)	N/A
N/A	Any Obstructions?	N/A	N/A	Storm Grate/Utility Hazard?	N/A
	Obstruction Type			Storm Grate/Utility Type	
		N/A			N/A
			Yes	Surface Condition? (G/P)	Good
			No	Curb Slope (%)	5.3

Possible Solutions:

Remove & Replace Curb Ramp With Two New Directional Ramps or Equivalent.
