Access Compliance Report

Public Rights-of-Way

(Curb Ramps)

Intersection ID: 43172	Main Street: N_TRYON_ST	Cross Street: KEMP_ST	Location:	NE
ADA ID: 6DD5DB94EA89	Ramp Type: Perp	Initial Pass/Fail: Fail	Overall Compliance: No	Severity Score: 10
Codes/Mitigation Info/Possible Solution		Field Measurements/Component Compliance

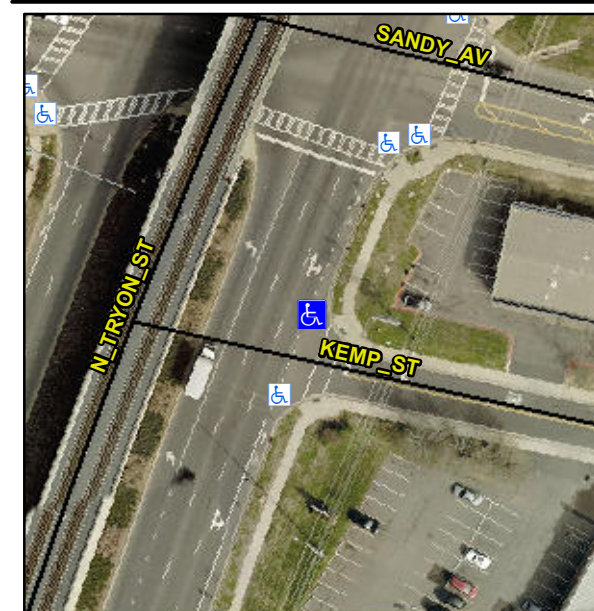
Not Found, R304.5.1, R304.5.3

Compliance	Description	Data	Compliance	Description	Data
N/A	Ramp Length (in)	60.0	Yes	Ramp Slope (%)	6.6
No	Ramp Width (in)	46.0	No	Ramp XSlope (%)	2.6
N/A	Flare Type LT	N/A	N/A	Flare Type RT	N/A
N/A	Flare Slope LT (%)	N/A	N/A	Flare Slope RT (%)	N/A
N/A	Flare Traversable LT?	N/A	N/A	Flare Traversable RT?	N/A
N/A	Landing Length (in)	N/A	N/A	DWS Provided?	N/A
N/A	Landing Width (in)	N/A	N/A	DWS Contrast?	N/A
N/A	Landing Slope (%)	N/A	N/A	DWS Length (in)	N/A
N/A	Landing X Slope (%)	N/A	N/A	DWS Full Width?	N/A
N/A	Landing Curb? (Y/N)	N/A	N/A	DWS Offset (in)	N/A
N/A	Shared Landing?	N/A			
N/A	Gutter Ponding?	N/A	N/A	Gutter Slope (%)	N/A
N/A	Gutter Lip Ht (in)	1.0	N/A	Gutter X Slope (%)	N/A
N/A	Painted X Walk1?	Yes	N/A	Painted X Walk2?	N/A
	X Walk 1 Direction	To SW		X Walk 2 Direction	N/A
N/A	X Walk 1 Width (in)	118.0	N/A	X Walk 2 Width (in)	N/A
	X Walk 1 Slope (%)	1.0		X Walk 2 Slope (%)	N/A
	X Walk 1 X Slope (%)	4.9		X Walk 2 X Slope (%)	N/A

Possible Solutions:

Remove & Replace Entire Ramp.

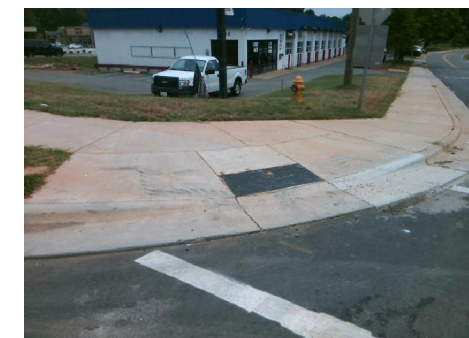
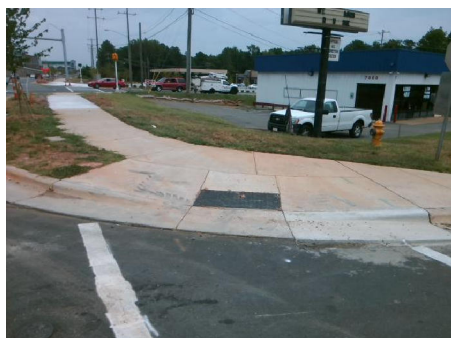
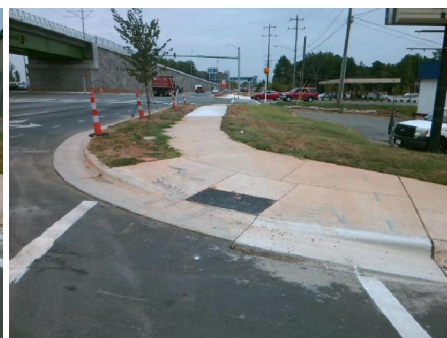
N/A	Ramp inside XWalk1?	Yes	N/A	Ramp inside XWalk2?	N/A
	Road Slope (%)	N/A	N/A	Clear Space?	N/A
	Road X Slope (%)	N/A	N/A	Clear Space to XWalk (in)	N/A
N/A	Any Obstructions?	N/A	N/A	Storm Grate/Utility Hazard?	N/A
	Obstruction Type			Storm Grate/Utility Type	
		N/A			N/A
		Yes		Surface Condition? (G/P)	Good
