Intersection ID: 9428	Main Street: DOUBLE_OAKS_RD	Cross Street: EUREKA_ST	Location:	NE
ADA ID: 6DDA670DCF7E	Ramp Type: Perp	Initial Pass/Fail: Fail	Overall Compliance: No	Severity Score: 46.25

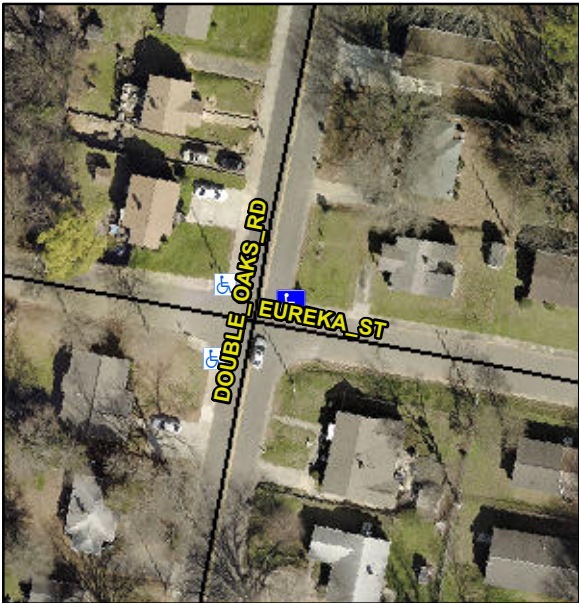
Possible Solutions:		Compliance	Description	Data	Compliance	Description	Data
	Remove & Replace Entire Ramp.		N/A	Ramp Length (in)	97.0	No	Ramp Slope (%)	10.5
			No	Ramp Width (in)	38.0	No	Ramp XSlope (%)	7.3
			N/A	Flare Type LT	N/A	N/A	Flare Type RT	N/A
			N/A	Flare Slope LT (%)	N/A	N/A	Flare Slope RT (%)	N/A
			N/A	Flare Traversable LT?	N/A	N/A	Flare Traversable RT?	N/A
			N/A	Landing Length (in)	N/A	N/A	DWS Provided?	N/A
			N/A	Landing Width (in)	N/A	N/A	DWS Contrast?	N/A
			N/A	Landing Slope (%)	N/A	N/A	DWS Length (in)	N/A
			N/A	Landing X Slope (%)	N/A	N/A	DWS Full Width?	N/A
Surveyor Notes:			N/A	Landing Curb? (Y/N)	N/A	N/A	DWS Offset (in)	N/A
N/A			N/A	Shared Landing?	N/A			
PROW/ADA:			N/A	Gutter Ponding?	N/A	N/A	Gutter Slope (%)	N/A
Not Found, R304.5.1, R304.2.2, R304.5.3			N/A	Gutter Lip Ht (in)	N/A	N/A	Gutter X Slope (%)	N/A

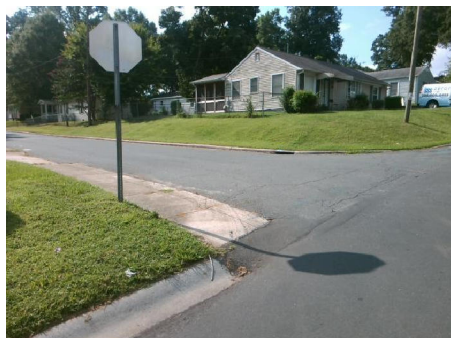
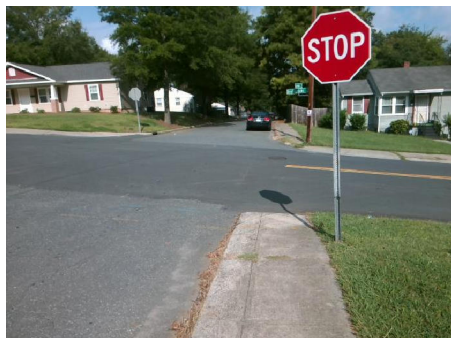
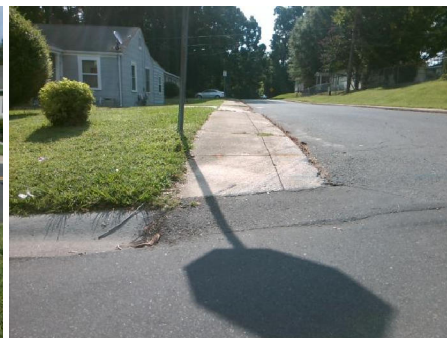
N/A	Painted X Walk1?	No	N/A	Painted X Walk2?	N/A
				X Walk 1 Direction	To W		X Walk 2 Direction	N/A
			N/A	X Walk 1 Width (in)	N/A	N/A	X Walk 2 Width (in)	N/A
				X Walk 1 Slope (%)	5.4		X Walk 2 Slope (%)	N/A
				X Walk 1 X Slope (%)	11.6		X Walk 2 X Slope (%)	N/A
Street 1 Name		DOUBLE OAKS RD	N/A	Ramp inside XWalk1?	N/A	N/A	Ramp inside XWalk2?	N/A
Stop Condition-Street 2		None		Road Slope (%)	N/A	N/A	Clear Space?	N/A
Street 2 Name		N/A		Road X Slope (%)	N/A	N/A	Clear Space to XWalk (in)	N/A
Stop Condition-Street 1		N/A	N/A	Any Obstructions?	N/A	N/A	Storm Grate/Utility Hazard?	N/A
Total Cost:		\$ 1850.00		Obstruction Type			Storm Grate/Utility Type	
					N/A			N/A
						Yes	Surface Condition? (G/P)	Good
