Access Compliance Report

Public Rights-of-Way

(Curb Ramps)

Intersection ID: 6766	Main Street: INDIAN RIDGE LN	Cross Street: WINDING CANYON DR	Location: W
ADA ID: 6DDBD0EC98A8	Ramp Type: Perp	Initial Pass/Fail: Fail	Overall Compliance: No
Severity Score: 12.5			
Codes/Mitigation Info/Possible Solution		Field Measurements/Component Compliance

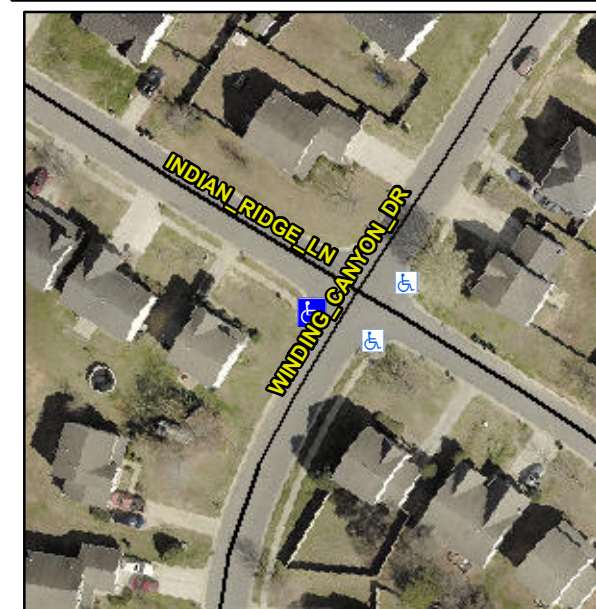
Compliance	Description	Data	Compliance	Description	Data
N/A	Ramp Length (in)	51.0	Yes	Ramp Slope (%)	6.1
Yes	Ramp Width (in)	48.0	No	Ramp XSlope (%)	5.3
N/A	Flare Type LT	N/A	N/A	Flare Type RT	N/A
N/A	Flare Slope LT (%)	N/A	N/A	Flare Slope RT (%)	N/A
N/A	Flare Traversable LT?	N/A	N/A	Flare Traversable RT?	N/A
N/A	Landing Length (in)	N/A	N/A	DWS Provided?	N/A
N/A	Landing Width (in)	N/A	N/A	DWS Contrast?	N/A
N/A	Landing Slope (%)	N/A	N/A	DWS Length (in)	N/A
N/A	Landing X Slope (%)	N/A	N/A	DWS Full Width?	N/A
N/A	Landing Curb? (Y/N)	N/A	N/A	DWS Offset (in)	N/A
N/A	Shared Landing?	N/A			
N/A	Gutter Ponding?	N/A	N/A	Gutter Slope (%)	N/A
N/A	Gutter Lip Ht (in)	1.0	N/A	Gutter X Slope (%)	N/A
N/A	Painted X Walk1?	No	N/A	Painted X Walk2?	N/A
	X Walk 1 Direction	To SE		X Walk 2 Direction	N/A
N/A	X Walk 1 Width (in)	N/A	N/A	X Walk 2 Width (in)	N/A
	X Walk 1 Slope (%)	8.3		X Walk 2 Slope (%)	N/A
	X Walk 1 X Slope (%)	3.3		X Walk 2 X Slope (%)	N/A

N/A	Ramp inside XWalk1?	N/A	N/A	Ramp inside XWalk2?	N/A
	Road Slope (%)	N/A	N/A	Clear Space?	N/A
	Road X Slope (%)	N/A	N/A	Clear Space to XWalk (in)	N/A
N/A	Any Obstructions?	N/A	N/A	Storm Grate/Utility Hazard?	N/A
	Obstruction Type			Storm Grate/Utility Type	
		N/A			N/A
		Yes		Surface Condition? (G/P)	Good

Possible Solutions:

Remove & Replace Entire Ramp.

R304.5.3
