Access Compliance Report

Public Rights-of-Way

(Curb Ramps)

Intersection ID: 19925	Main Street: SARDIS_RD	Cross Street: PROVIDENCE_RD	Location: NW
ADA ID: 6DDF5139E774	Ramp Type: Perp	Initial Pass/Fail: Fail	Overall Compliance: No
Severity Score: 8.75			
Codes/Mitigation Info/Possible Solution		Field Measurements/Component Compliance

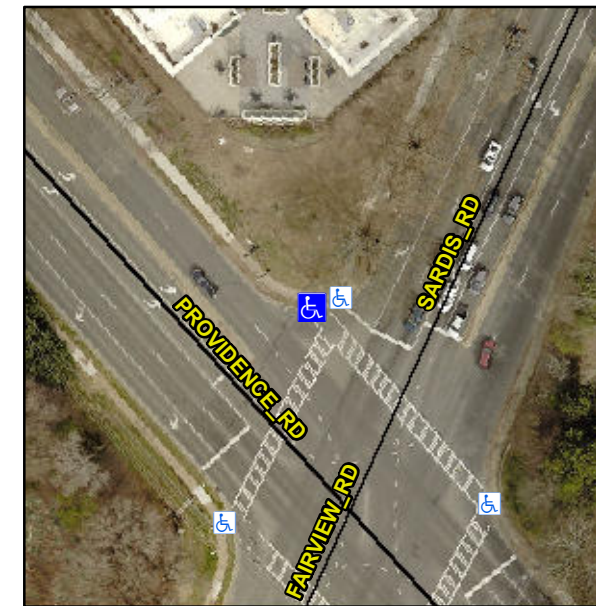
Not Found, R304.5.1

Compliance	Description	Data	Compliance	Description	Data
N/A	Ramp Length (in)	48.0	Yes	Ramp Slope (%)	5.1
No	Ramp Width (in)	42.0	Yes	Ramp XSlope (%)	0.5
N/A	Flare Type LT	N/A	N/A	Flare Type RT	N/A
N/A	Flare Slope LT (%)	N/A	N/A	Flare Slope RT (%)	N/A
N/A	Flare Traversable LT?	N/A	N/A	Flare Traversable RT?	N/A
N/A	Landing Length (in)	N/A	N/A	DWS Provided?	N/A
N/A	Landing Width (in)	N/A	N/A	DWS Contrast?	N/A
N/A	Landing Slope (%)	N/A	N/A	DWS Length (in)	N/A
N/A	Landing X Slope (%)	N/A	N/A	DWS Full Width?	N/A
N/A	Landing Curb? (Y/N)	N/A	N/A	DWS Offset (in)	N/A
N/A	Shared Landing?	N/A			
N/A	Gutter Ponding?	N/A	N/A	Gutter Slope (%)	N/A
N/A	Gutter Lip Ht (in)	N/A	N/A	Gutter X Slope (%)	N/A
N/A	Painted X Walk1?	Yes	N/A	Painted X Walk2?	N/A
	X Walk 1 Direction	To SW		X Walk 2 Direction	N/A
N/A	X Walk 1 Width (in)	108.0	N/A	X Walk 2 Width (in)	N/A
	X Walk 1 Slope (%)	1.0		X Walk 2 Slope (%)	N/A
	X Walk 1 X Slope (%)	0.3		X Walk 2 X Slope (%)	N/A

N/A	Ramp inside XWalk1?	Yes	N/A	Ramp inside XWalk2?	N/A
	Road Slope (%)	N/A	N/A	Clear Space?	N/A
	Road X Slope (%)	N/A	N/A	Clear Space to XWalk (in)	N/A
N/A	Any Obstructions?	N/A	N/A	Storm Grate/Utility Hazard?	N/A
	Obstruction Type			Storm Grate/Utility Type	
		N/A			N/A
		Yes		Surface Condition? (G/P)	Good

Remove & Replace Entire Ramp.

Total Cost: \$ 1850.00
