# Access Compliance Report

## Public Rights-of-Way

### (Curb Ramps)

Intersection ID: 10519	Main Street: HAMILTON_ST	Cross Street: POLK_ST	Location:	N
ADA ID: 6DFC5079EB08	Ramp Type: Perp	Initial Pass/Fail: Fail	Overall Compliance: No	Severity Score: 21.25
Codes/Mitigation Info/Possible Solution		Field Measurements/Component Compliance

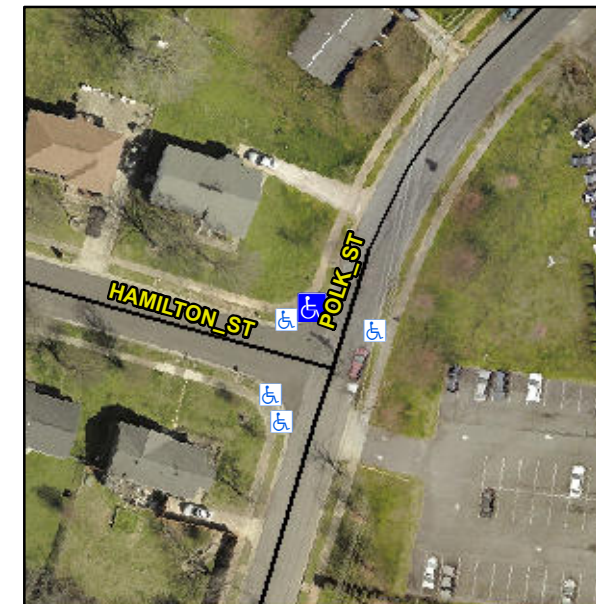
**Not Found, R304.5.1, R304.5.3**

Compliance	Description	Data	Compliance	Description	Data
N/A	Ramp Length (in)	52.0	Yes	Ramp Slope (%)	5.6
No	Ramp Width (in)	41.0	No	Ramp XSlope (%)	5.1
N/A	Flare Type LT	N/A	N/A	Flare Type RT	N/A
N/A	Flare Slope LT (%)	N/A	N/A	Flare Slope RT (%)	N/A
N/A	Flare Traversable LT?	N/A	N/A	Flare Traversable RT?	N/A
N/A	Landing Length (in)	N/A	N/A	DWS Provided?	N/A
N/A	Landing Width (in)	N/A	N/A	DWS Contrast?	N/A
N/A	Landing Slope (%)	N/A	N/A	DWS Length (in)	N/A
N/A	Landing X Slope (%)	N/A	N/A	DWS Full Width?	N/A
N/A	Landing Curb? (Y/N)	N/A	N/A	DWS Offset (in)	N/A
N/A	Shared Landing?	N/A			
N/A	Gutter Ponding?	N/A	N/A	Gutter Slope (%)	N/A
N/A	Gutter Lip Ht (in)	1.5	N/A	Gutter X Slope (%)	N/A
N/A	Painted X Walk1?	No	N/A	Painted X Walk2?	N/A
	X Walk 1 Direction	To SE		X Walk 2 Direction	N/A
N/A	X Walk 1 Width (in)	N/A	N/A	X Walk 2 Width (in)	N/A
	X Walk 1 Slope (%)	1.7		X Walk 2 Slope (%)	N/A
	X Walk 1 X Slope (%)	1.3		X Walk 2 X Slope (%)	N/A

N/A	Ramp inside XWalk1?	N/A	N/A	Ramp inside XWalk2?	N/A
	Road Slope (%)	N/A	N/A	Clear Space?	N/A
	Road X Slope (%)	N/A	N/A	Clear Space to XWalk (in)	N/A
N/A	Any Obstructions?	N/A	N/A	Storm Grate/Utility Hazard?	N/A
	Obstruction Type			Storm Grate/Utility Type	
		N/A			N/A
			Yes	Surface Condition? (G/P)	Good

**Remove & Replace Entire Ramp.**

Total Cost: \$ 1850.00
