Access Compliance Report Public Rights-of-Way (Curb Ramps)

Intersection ID: 10038266Main Street: SMITHFIELD_CHURCH_RDCross Street: N/ALocation:NEADA ID: 6DFC71BAC9B6Ramp Type: PerpInitial Pass/Fail: FailOverall Compliance: NoSeverity Score:22.5

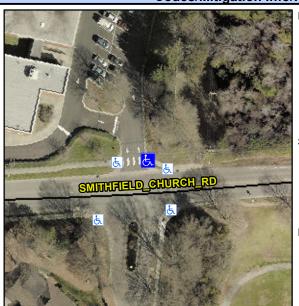
Field Measurements/Component Compliance						
Compli	ance Description	Data	Compli	iance Description	Data	
N/A	Ramp Length (in)	46.0	No	Ramp Slope (%)	8.5	
No	Ramp Width (in)	46.5	No	Ramp XSlope (%)	3.7	
N/A	Flare Type LT	N/A	N/A	Flare Type RT	N/A	
N/A	Flare Slope LT (%)	N/A	N/A	Flare Slope RT (%)	N/A	
N/A	Flare Traversable LT?	N/A	N/A	Flare Traversable RT?	N/A	
N/A	Landing Length (in)	N/A	N/A	DWS Provided?	N/A	
N/A	Landing Width (in)	N/A	N/A	DWS Contrast?	N/A	
N/A	Landing Slope (%)	N/A	N/A	DWS Length (in)	N/A	
N/A	Landing X Slope (%)	N/A	N/A	DWS Full Width?	N/A	
N/A	Landing Curb? (Y/N)	N/A	N/A	DWS Offset (in)	N/A	
N/A	Shared Landing?	N/A				
N/A	Gutter Ponding?	N/A	N/A	Gutter Slope (%)	N/A	
N/A	Gutter Lip Ht (in)	N/A	N/A	Gutter X Slope (%)	N/A	
N/A	Painted X Walk1?	Yes	N/A	Painted X Walk2?	N/A	
	X Walk 1 Direction	To W		X Walk 2 Direction	N/A	
N/A	X Walk 1 Width (in)	60.0	N/A	X Walk 2 Width (in)	N/A	
	X Walk 1 Slope (%)	0.3		X Walk 2 Slope (%)	N/A

X Walk 1 X Slope (%)	1.9		X Walk 2 X Slope (%)	N/A	
N/A	Ramp inside XWalk1?	Yes	N/A	Ramp inside XWalk2?	N/A	
	Road Slope (%)	N/A	N/A	Clear Space?	N/A	
	Road X Slope (%)	N/A	N/A	Clear Space to XWalk (in)	N/A	
N/A	Any Obstructions?	N/A	N/A	Storm Grate/Utility Hazard?	N/A	
	Obstruction Type			Storm Grate/Utility Type		
		N/A			N/A	
			Yes	Surface Condition? (G/P)	Good

rossible solution	
Possible Solutions:	9
Remove & Replace Entire Ramp.	ı
·	ı
	ı
	ı
	ı
	ı
Surveyor Notes:	ı
N/A	I
	ı
	ı
	ı
PROW/ADA:	I
Not Found, R304.5.1, R304.2.2,	ı
R304.5.3	I
	ı
