# Access Compliance Report

## Public Rights-of-Way

### (Curb Ramps)

| Intersection ID: 12426 | Main Street: KENWOOD_AV | Cross Street: MIDWOOD_PL | Location: SW |

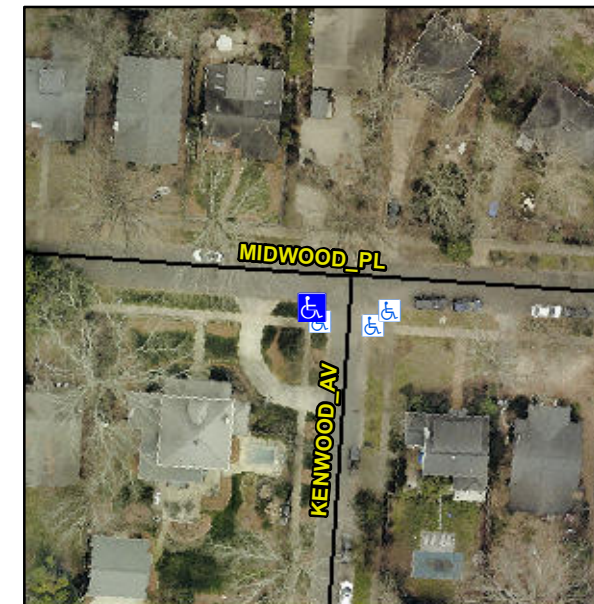
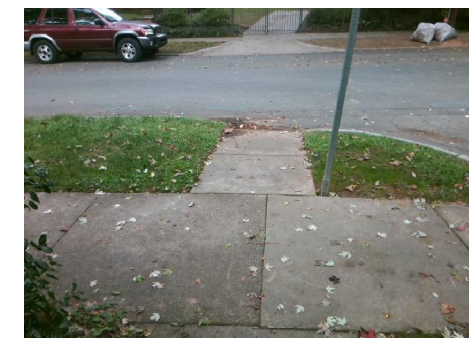
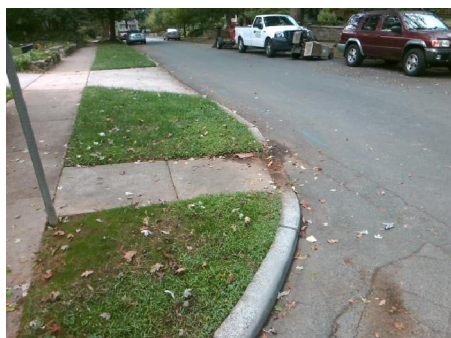
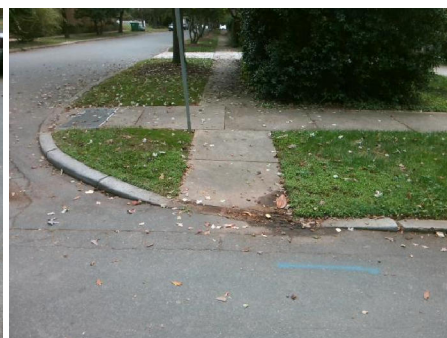
| ADA ID: 6E0711A5F20D | Ramp Type: Perp | Initial Pass/Fail: Fail | Overall Compliance: No |

**Not Found, R304.5.1, R304.2.2, R304.5.3**

| Compliance | Description | Data | Compliance | Description | Data |
|---|---|---|---|---|---|
| N/A | Ramp Length (in) | 40.0 | No | Ramp Slope (%) | 8.5 |
| No | Ramp Width (in) | 47.0 | No | Ramp XSlope (%) | 4.2 |
| N/A | Gutter Ponding? | Yes | N/A | Gutter Slope (%) | N/A |

**Remove & Replace Entire Ramp.**

Total Cost: \$ 1850.00
